Course Number: CE-02-207

Technical Manual for Dam Owners

Impacts of Plants on Earthen Dams

FEMA 534 / September 2005

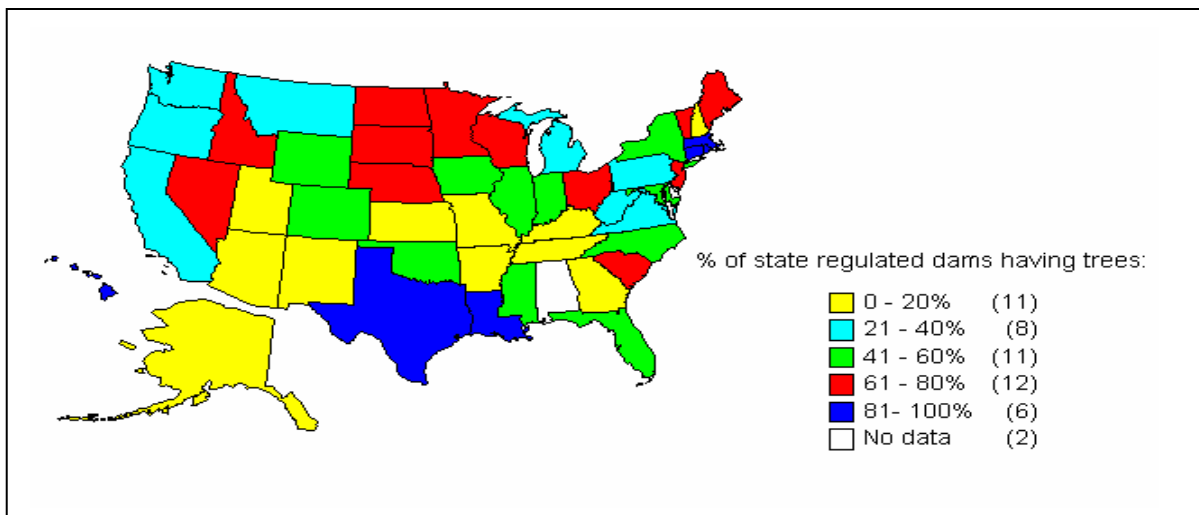
Figure 1. Estimated percentages of state-regulated dams having trees.

Figure 4 gives a breakdown of the percentage ranges of regulated dams where the 48 reporting state dam safety officials shown in Figure 1 estimate that trees and brush hinder safety inspections in their respective states (ASDSO, 1999). While half the states report having only 20 percent or fewer dams with significant trees and woody vegetation that hinder inspections, vegetation on an estimated 30,000 or nearly a third of the collective state-regulated dams, is reported to obstruct effective dam safety inspections.

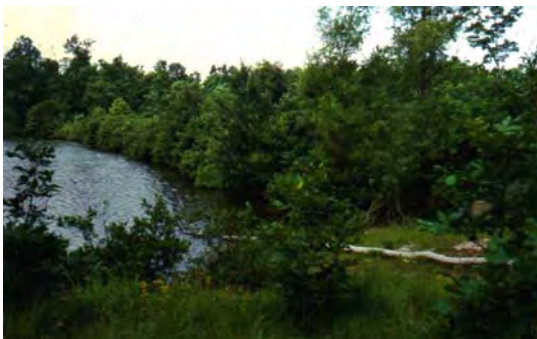
Figure 3. Example dam with inspection-hindering trees in Tennessee.

The problem most commonly noted by state officials is that trees, woody vegetation, briars, and vines interfere with effective safety inspections. Figure 3 illustrates this problem for a dam located in Tennessee.

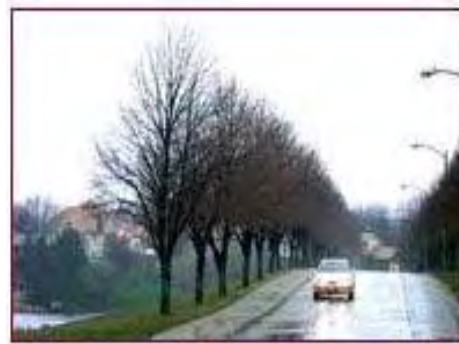
Figure 2. Example dam with problematic trees in Nebraska.

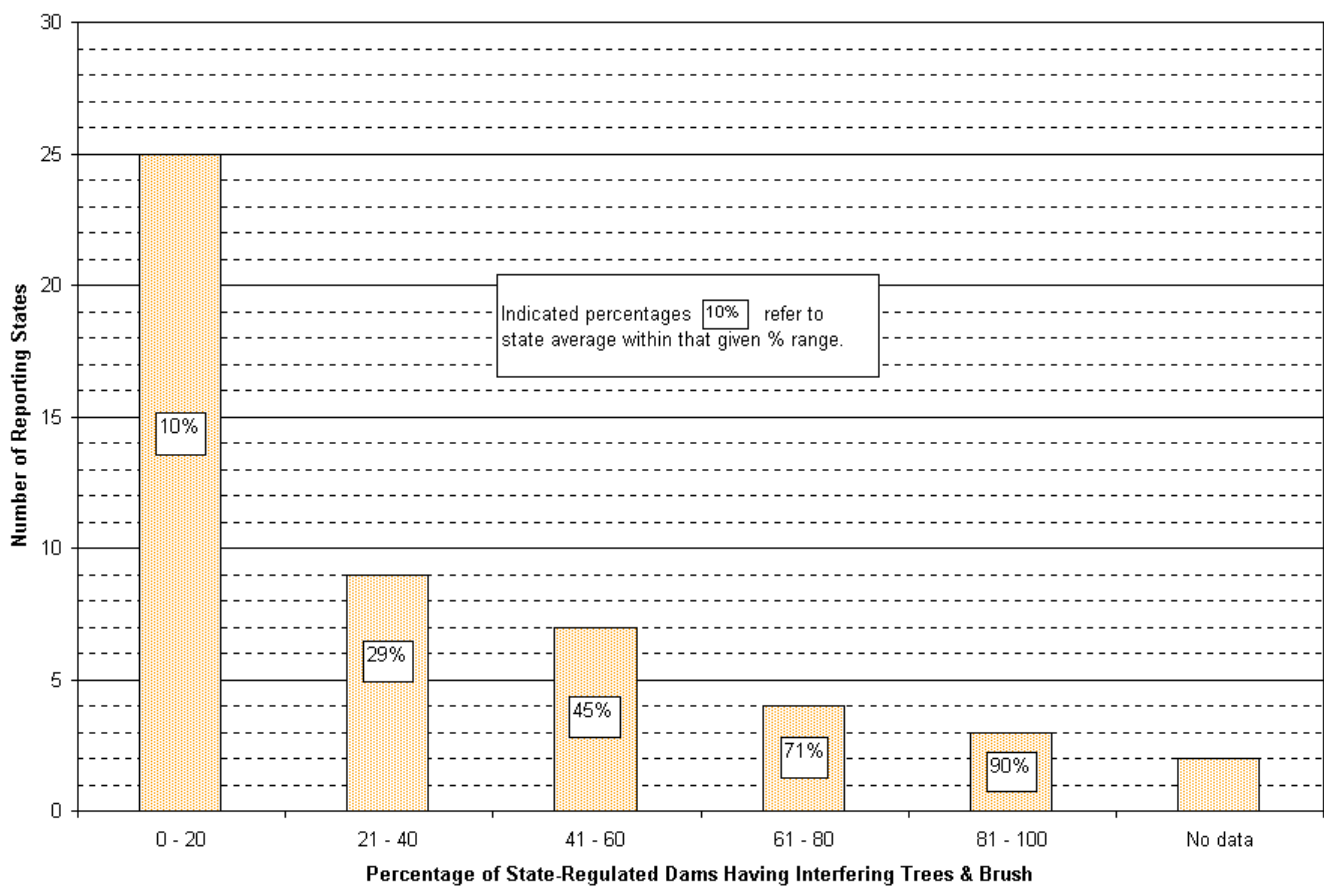
Figure 4. Estimated percentages of state-regulated dams where trees and brush are considered a deterrent to effective safety inspections.

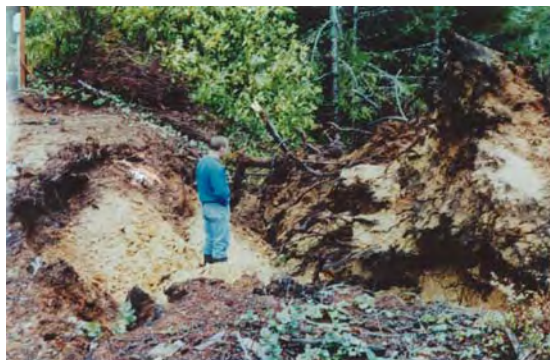
Figure 5. Serious damage by uprooted tree to embankment stability at a dam in Oregon.

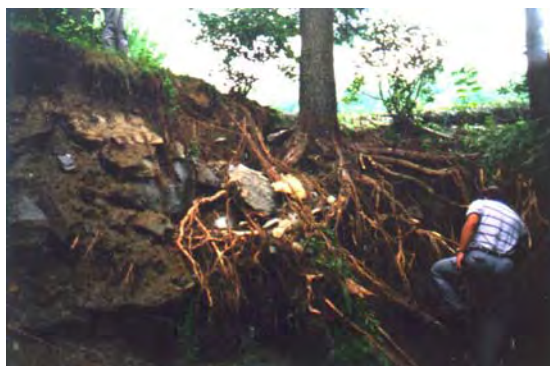
Figure 6. Tree root induced scouring on crest and downstream face of Coffey dam in Kansas.

- Inducing local turbulence and scouring around trees in emergency spillways and during overtopping as shown in Figure 6.

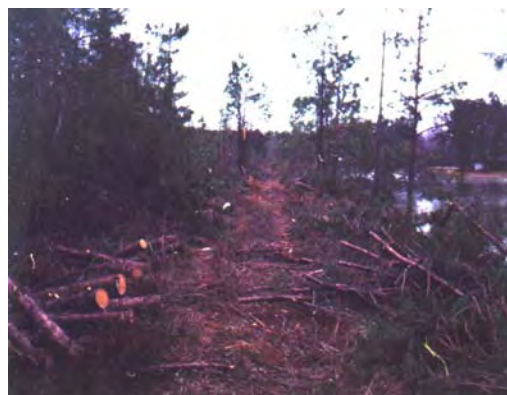
Figure 6. Trees cut prior to removing stumps and roots from dam.

Figures 6 and 7 illustrate extensive efforts necessary to restore a heavily wooded earthen dam to a desirable vegetated and maintained condition.

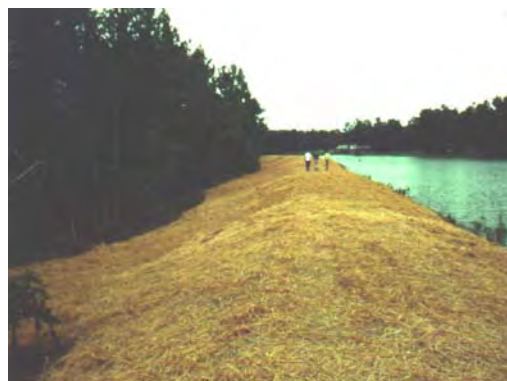
Figure 7. Completed remediation job after removing stumps, seeding, fertilizing & mulching.

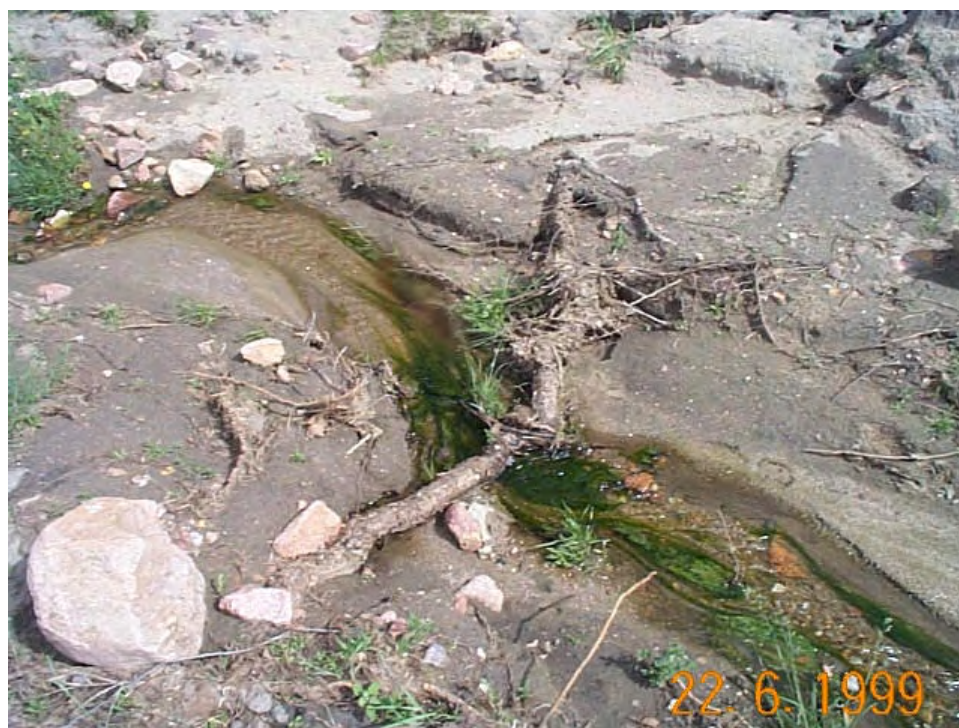
Figure 9. Large pine tree root located in the channel of the breach opening of a failed Air Force Academy waste lagoon pond dam (David Eyre, Senior Civil Engineer, Air Force Academy, Colorado, 1999).

safety problems. The most recent documented dam failure due to tree root penetration occurred in May 1999 at an unnamed Air Force Academy dam near Colorado Springs. Here, an approximately 13-ft. high dam with a pond capacity of less than 5 acre-feet of horse stable waste water failed, releasing its contents and injuring a horse in a stable located about 100 yards downstream. The failure occurred after more than 7 inches of rain had fallen in the previous 72 hours. The dam had several pine trees on its crest and faces, and the breach opening exposed an extensive, deep root system. Roots up to 4 inches in diameter were found in the breach area. Figure 9 shows an example of a large root exposed in the bottom of the channel at the breach. The dam had not overtopped, and the failure was attributed to internal erosion of the decomposed granite embankment material along the roots. A tree had been located directly over the breach.

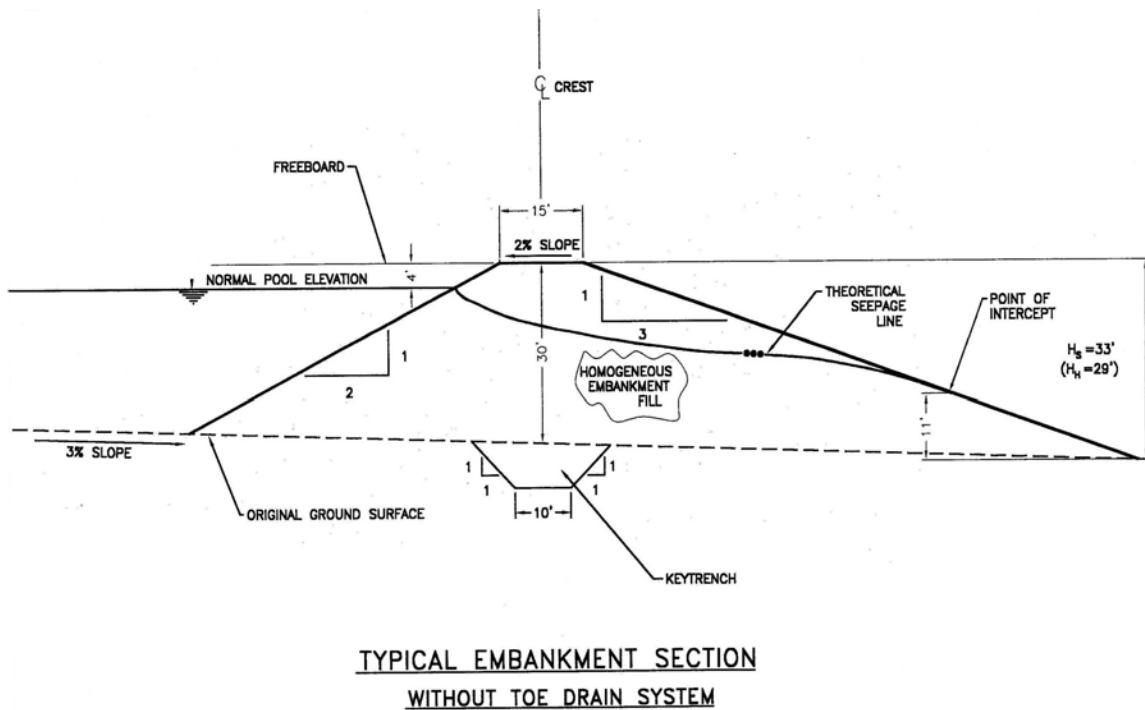
The configuration of the example earthen dam consists of an upstream slope of 2:1 (horizontal to vertical), a crest width of fifteen feet, and a 3:1 (horizontal to vertical) downstream slope. The dam has a freeboard of four feet making the hydraulic height of the dam about 29 feet. The dam is founded on relatively impervious (compared to the embankment fill soil) material with a down gradient slope of about three percent. The example earthen dam section has a key trench directly below the centerline of the dam crest that has a bottom width of ten feet and side slopes of 1:1 (horizontal to vertical). The dam crest has a two-percent slope toward the impounded lake and the upstream slope has no protection system against tree and woody vegetation growth or wave erosion. The embankment of the example earthen dam is assumed to be homogeneous. Figure 1 is a representation of the example earthen dam configuration with the theoretical seepage line intercepting the downstream slope at about one-third the hydraulic height of the dam.

Rule-of-Thumb: *The phreatic surface intercepts the downstream slope of a homogeneous earthen dam at a vertical distance of about one-third the hydraulic height above the toe of the downstream slope, provided there is no internal drainage system in the dam embankment.*

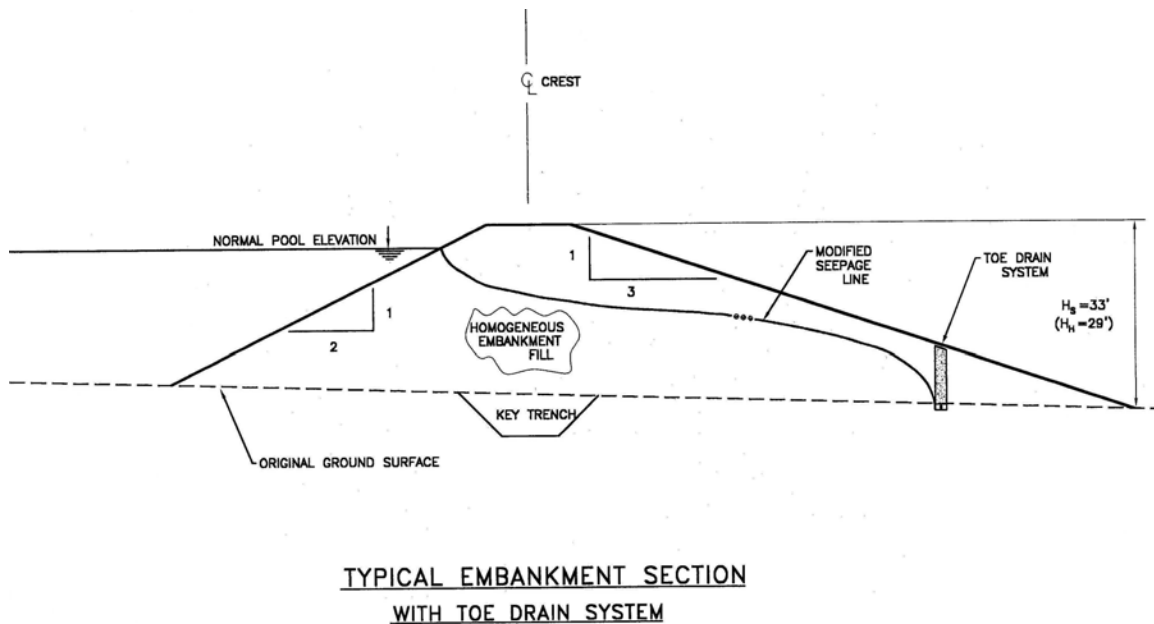
Figure 2 illustrates the example earthen dam with an embankment subdrain system located within the downstream embankment slope. The subdrain or embankment drain system is located at about the point of interception of the seepage line with the downstream slope if there was no embankment toe drain system within the downstream slope. As a result of the presence of the embankment subdrain system, the seepage line through the dam embankment has been modified (lowered) from the location of the theoretical seepage line for a homogeneous earthen dam embankment. The seepage line within an earthen dam is often mistakenly considered to have a permanent location.

However, the location of the seepage line is continually changing as a result of many influential factors. Fluctuations in the pool elevation, seasonal and long-term climatological conditions, and the growth of trees and woody vegetation in close proximity to the seepage line are some of the factors that influence changes in the location of the phreatic surface within an earthen dam embankment.

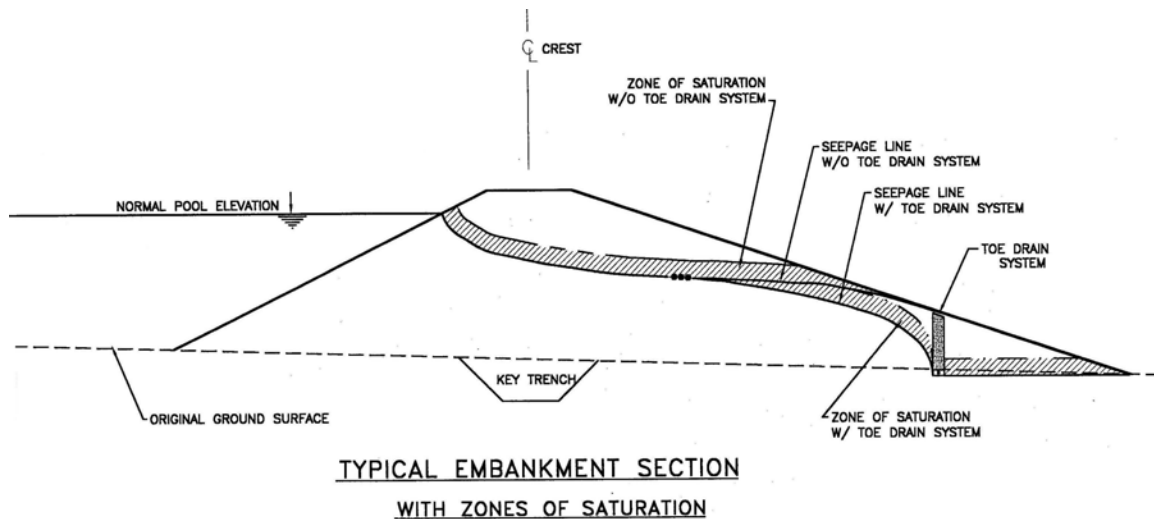
Important moisture regimes other than the steady-state seepage line (phreatic surface) are often not given proper consideration in the evaluation of the performance of earthen dams. The *zone of saturation* is located immediately above the phreatic surface or seepage line where embankment fill soils have become saturated as a result of capillary rise caused by capillary forces in the soil voids. Figure 3 illustrates the presence of zones of saturation associated with that of a theoretical seepage line location without an embankment subdrain system as well as that of a modified seepage line location with an embankment toe drain system. The height of capillary rise (thickness of the zone of saturation) is directly dependent upon the effective mean diameter of soil voids within the earthen dam embankment. The effective mean diameter of compacted soil is dependent upon the *effective particle size* (D_e) of the compacted embankment fill soil. Soil within

the zone of saturation is completely saturated; however, there is no flow or gravity induced movement of water unless some external force disturbs the soil. This phenomenon is often observable during the inspection of downstream slopes of earthen

dams. Seepage and free flowing water can be seen on the downstream slope of an older dam below the point of interception of the seepage line if no embankment subdrain is present. Above the point of interception of the seepage line with the downstream slope, the soil is saturated and the Zone of Saturation can be observed for a significant distance above the seepage line intercept in some cases. In the Zone of Saturation, pore water may be observed to fill tracks made in the water-softened embankment soil. However, once the tracks are filled by pore water released from the disturbed soil there will be no continued flow or seepage from the embankment. This condition is often confused with the presence of embankment seepage. Installation of a subdrain location in this situation may lower the phreatic surface relatively quickly; however, months or even years may be required to drain the zone of saturation because of tensile forces or negative pore pressures in the embankment fill soils.

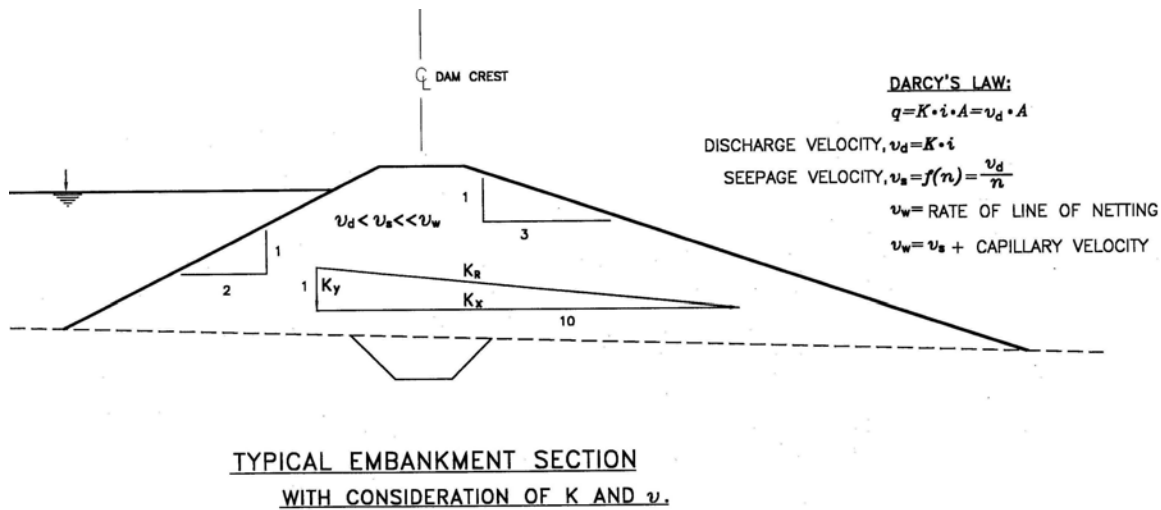
Figure 4 is an illustration of the example earthen dam with relationships between various soil water flow velocities and permeabilities. First, consider the relationship between the vertical and horizontal permeability of a compacted homogeneous embankment soil.

Rule-of-Thumb: *The horizontal permeability of a compacted homogeneous embankment soils are typically about nine times to ten times (one order of magnitude) greater than the vertical permeability.*

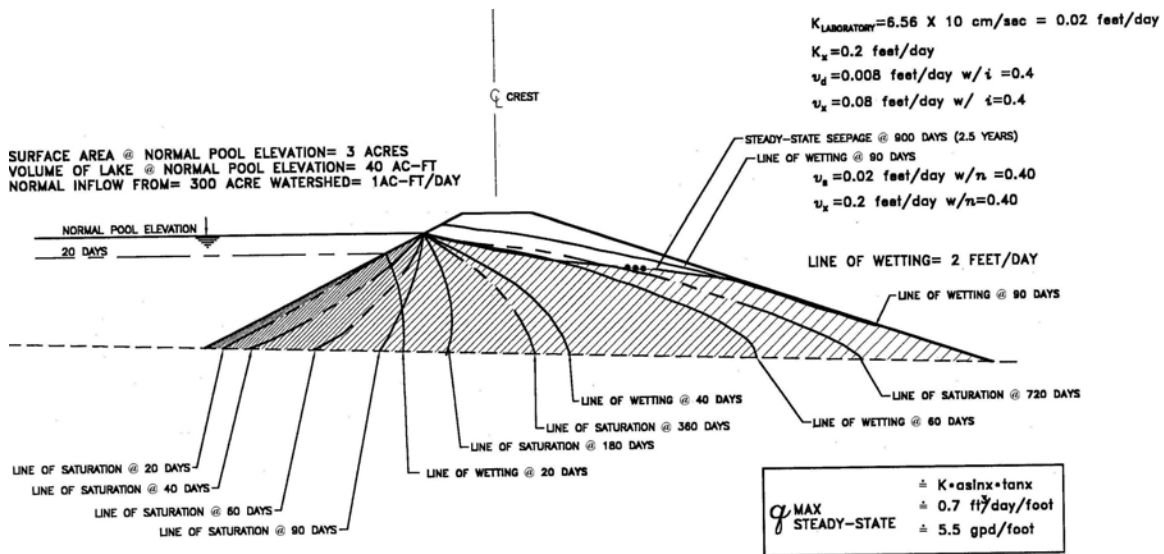
Figure 5

Applying this factor to the previous comparison between seepage velocity and discharge velocity, one finds that the wetting velocity is about 25 times greater than the discharge velocity. Based upon the foregoing discussion of earthen dam embankment wetting, saturation, and steady-state seepage velocities, consider the illustration in Figure 5. This figure illustrates embankment wetting, saturation, and steady-state seepage during the early years of the design life of an earthen dam. Assume that laboratory testing indicates that embankment soils of the example dam embankment have a permeability or hydraulic conductivity value of 0.02 foot per day. The discharge velocity would be about 0.008 foot per day with a hydraulic gradient of about 0.4 resulting in a horizontal discharge velocity of about 0.08 foot per day. The associated seepage velocity would be about 0.02 foot per day with a soil porosity of about 40 percent and the horizontal seepage velocity would be about 0.2 foot per day. The velocity of the line of wetting or the wetting velocity would be about 2.0 feet per day.

**PROGRESSION OF EMBANKMENT WETTING & SATURATION
WITHOUT CONSIDERATION OF VEGETATION**

Even without the presence of an embankment subdrain system, the time required for the line of wetting could encompass an entire growing season depending upon the time of year that the dam was completed. More importantly, the time that is required for the line of saturation to intercept the downstream slope might encompass two or three entire growing seasons. Tree and woody vegetation growth can become quite dense and relatively large within the initial two to three growing seasons if not properly controlled.

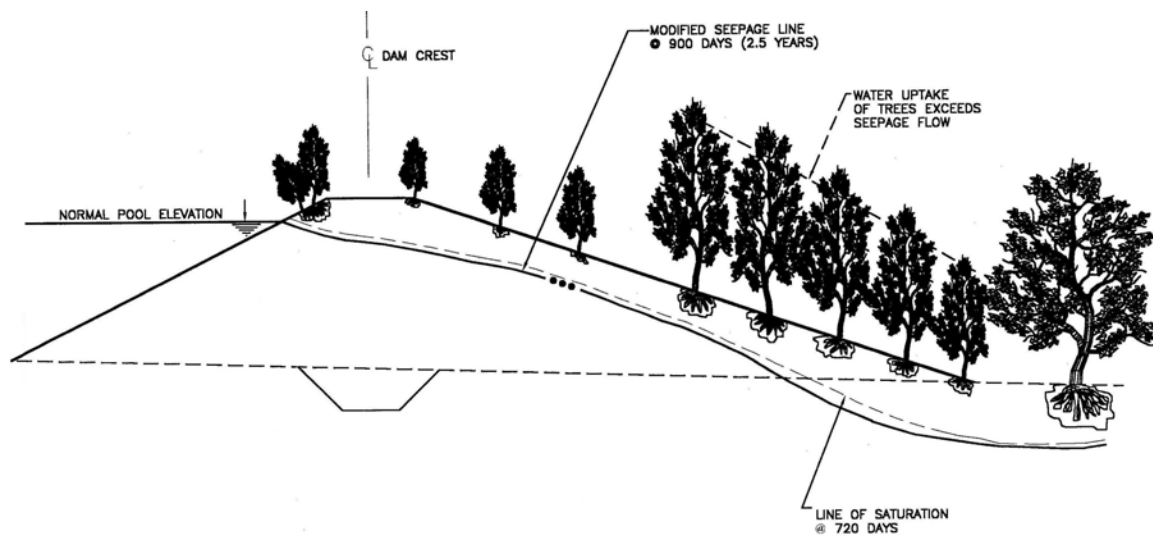
The initiation of tree and woody vegetation growth on the downstream slope begins the soil moisture uptake cycle so that the line of saturation and the seepage line may never completely develop and intercept the downstream slope. The condition represented by Figure 6 might initially be considered to be beneficial to the stability of the dam embankment. However, one must understand that as the tree and woody vegetation growth continues compacted soils of the dam embankment are continually loosened by the penetration of major tree and woody vegetation root systems. Furthermore, trees that might appear healthy to an untrained inspector may be an unhealthy specimen and have a premature death leaving penetrating root systems to rot inside the dam embankment. Additionally, soil nutrients in the compacted soil embankment of an earthen dam may not be sufficient for development of growth beyond which the tree cannot be properly sustained without premature death. Regardless of the cause, trees and woody vegetation do die and cease to uptake soil moisture that they previously used. This change in soil moisture uptake will affect the zone of aeration, zone of saturation, and the location of the seepage line in the vicinity of the unhealthy or dead trees and woody vegetation.

MODIFICATION OF SEEPAGE LINE
WITH TREES & WOODY VEGETATION

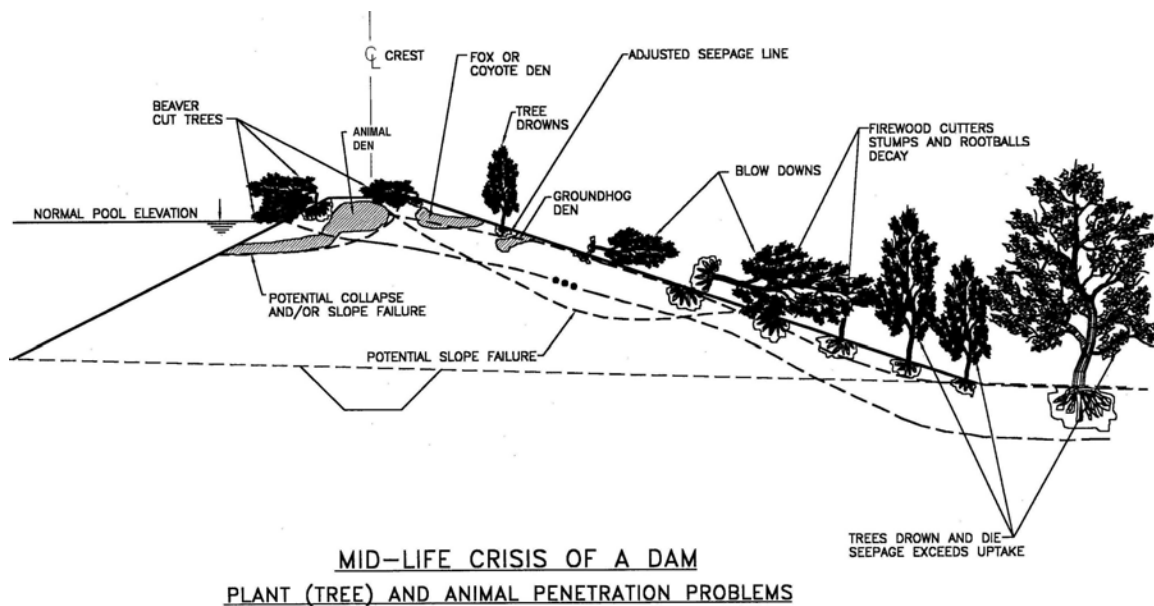
Figure 7 illustrates some of the problems and dam safety issues that can be created by uncontrolled or non-maintained tree and woody vegetation growth in what has been termed by the author as the '*Mid-Life Crisis*' of an earthen dam. Seepage flow may be emerging from rootball cavities of blowdowns (uprooted trees) because they are no longer using soil moisture and the seepage line has adjusted upward toward the surface of

the slope. Removal of mature trees by woodcutters deletes the soil moisture uptake of the removed trees thus further modifying the location of the seepage line closer to the surface of the downstream slope. Rootballs and root systems of otherwise healthy trees located at and beyond the toe of the downstream embankment slope become inundated by the adjusted seepage line. Since trees cannot live through prolonged submergence of their major root systems, these trees will become unhealthy and die leaving decaying rootballs and root systems as serious penetrations in the earthen dam. Rootball cavities remaining from blowdowns (uprooted trees) and their relationship to the seepage line create conditions susceptible to potential slope failure of the downstream embankment slope. Restoration of the example earthen dam illustrated in Figure 7 to a safe condition cannot be brought about through routine maintenance activities. An *engineered* dam remediation design and remediation construction will be required to restore this dam to a safe condition and original design life.

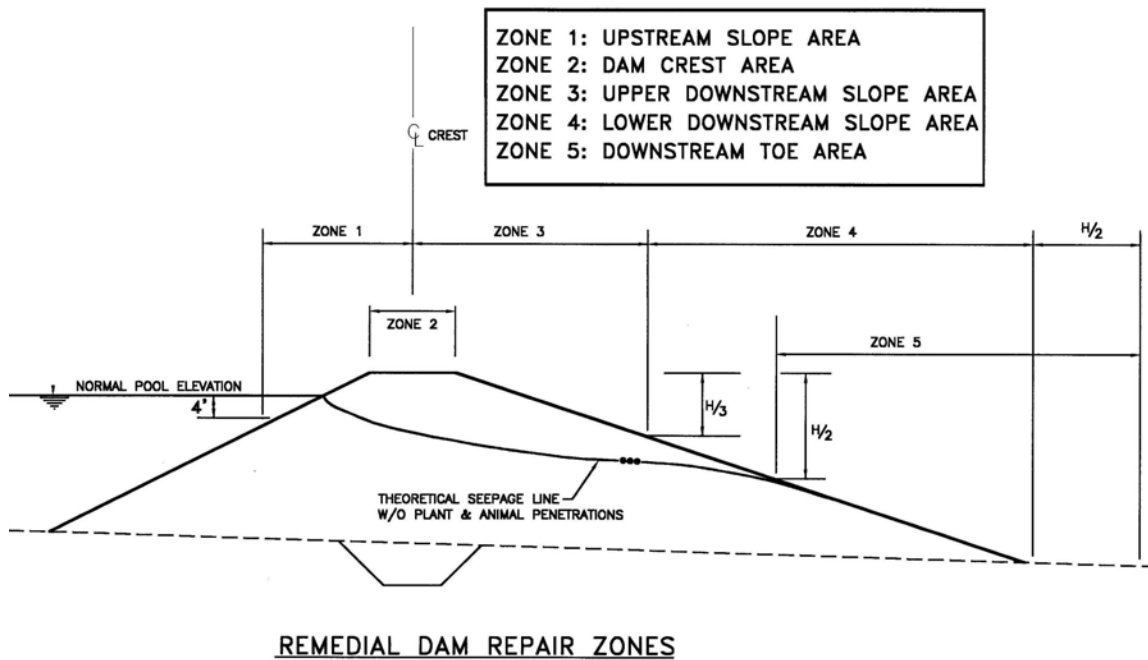
Figure 8

Five dam safety inspection and evaluation zones have been identified within the geometric configuration of a typical earthen dam. The delineated zones, illustrated in Figure 8, are not numbered in any implied order of seriousness relative to the impact of tree and woody vegetation growth, but have simply been numbered from upstream to downstream. The seriousness and potential impacts of tree and woody vegetation growth within each inspection and evaluation zone will be discussed during the description and identification of the delineated dam safety inspection and evaluation zones.

Inspection and Evaluation Zone 1 begins on the upstream slope of the earthen dam embankment at about four feet below normal pool elevation. Zone 1 extends laterally to the centerline of the crest of the dam. Tree and woody vegetation growth in Zone 1 is more critical relative to dam safety in the case of dams having a narrow crest width than those having a wide crest width. Zone 1 also includes the area subject to damage resulting from wave erosion and frequently recurring rapid drawdown events.

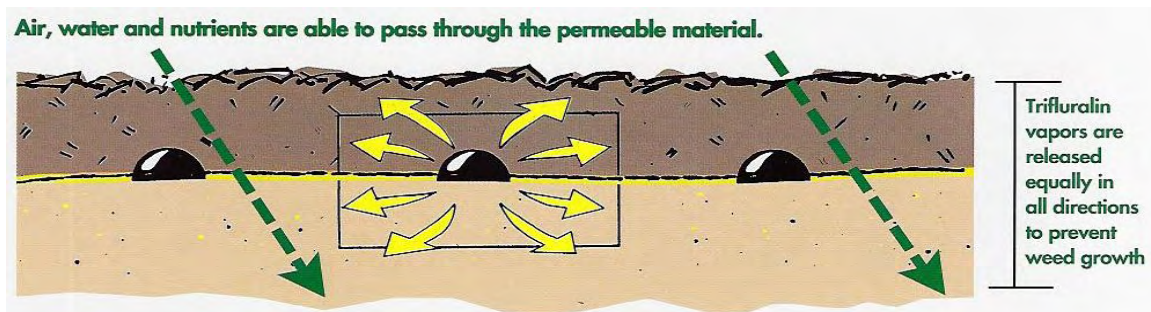
One typical biocide product, called “Biobarrier©” is marketed and promoted, among other applications such as sidewalk and landfill cap protection, to prevent tree and plant roots from penetrating dams. The product consists of long-term, slow release nodules containing Trifluralin herbicide, that are bonded to a geotextile fabric as shown in Figure 1.

Figure 1. Chemical biocide barrier installation showing slow-releasing biocide nodules attached in a woven fabric matrix and installed under a cover of soil, mulch, gravel or stone (Biobarrier©).

This particular barrier is environmentally acceptable to EPA and indicated to be effective against all types of roots around pipes, hardscapes, and dams and levees. While the product is guaranteed for 15 years, its life is inversely proportional to environmental temperature conditions.

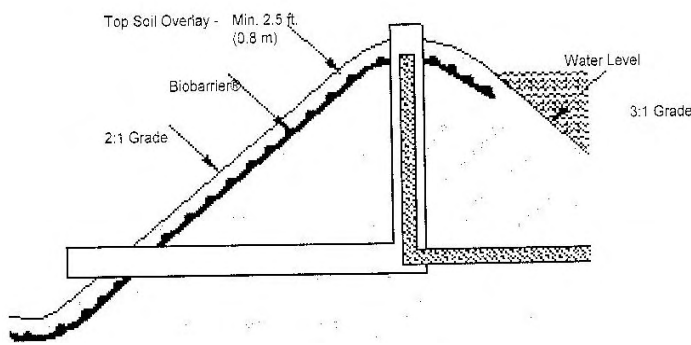
Figure 2. Earth dam installation of chemical

For example, its effectiveness is expected to be about 40 years at 20°C (68°F) and about 100 years at 15°C (60°F). For deep soil cover, it is expected to last 100 years; for near soil-surface weed control installations, where temperatures are higher and cycle daily, the projected life is expected to exceed the guaranteed 15-year life. Figures 2 and 3 show an application of this product on a 25-foot high and 350-foot long earthen dam to prevent deep penetration of deep-rooting native trees and woody vegetation such as willows, sagebrush, and chokecherries.

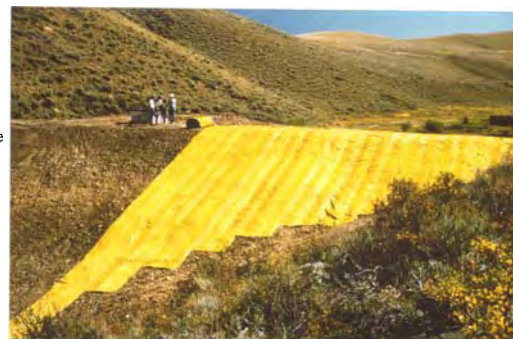
Figure 3. Installed chemical barrier on a dam in Montana (Kershner, 1992)

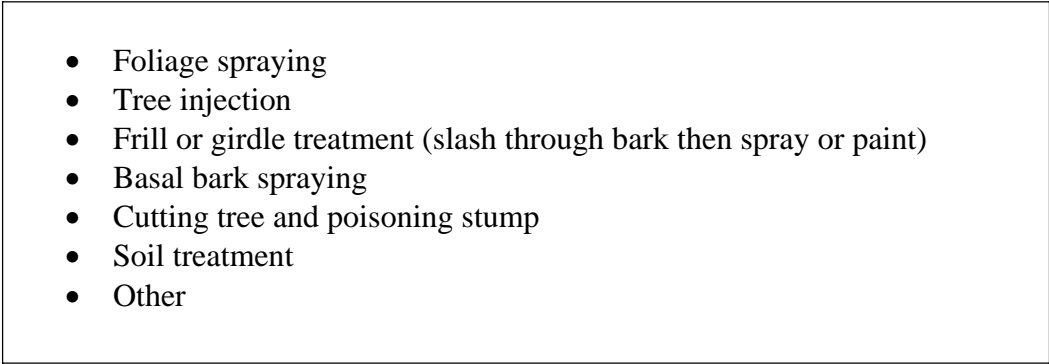
- Foliage spraying
 - Tree injection
 - Frill or girdle treatment (slash through bark then spray or paint)
 - Basal bark spraying
 - Cutting tree and poisoning stump
 - Soil treatment
 - Other

Figure 4. Herbicide delivery application methods

also encouraged to consult with a local county extension office or agent to obtain advice on the best and safest herbicide to use and on what recommended application technique to use. While there are several herbicidal delivery methods available, the most common techniques are shown below in Figure 4.

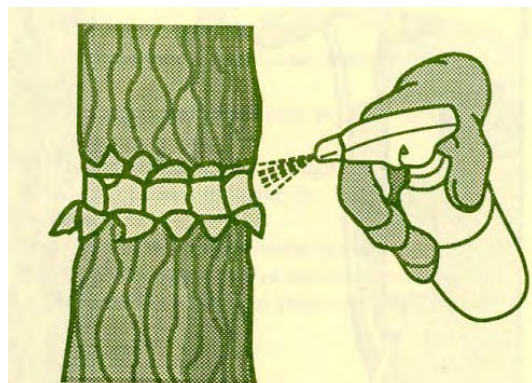
Vanquish
Weedone
Chopper
Pathway
Tordon
Arsenol

Figure 5a. Frill cut application.

Some of these techniques and herbicides used are illustrated in Figures 5a – 5f. The U. S. Department of Agriculture (SCS, now NRCS) published a useful methods, treatment points, and time of treatment guidelines for controlling trees and brush on dams, including some of the applications listed in Figure 4 (USDA, 1988). Table 4 summarizes the USDA recommendations. With the exception of Krenite, which is applied to the foliage, 2,4-D is the only approved herbicide for poisoning trees on dams. 2, 4-D is manufactured by several companies and is sold under several trade names. In all cases, the user is cautioned again to follow the manufacturer's instructions and should consider the manufacturer's label instructions to supercede recommended instructions in the USDA table.

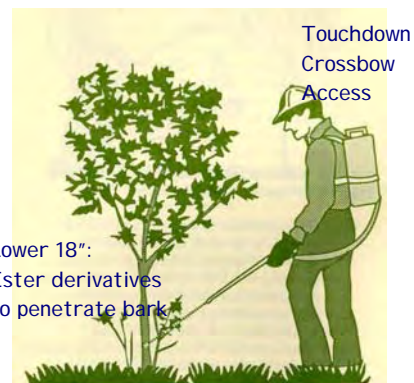
Figure 5b. Basal bark spraying.

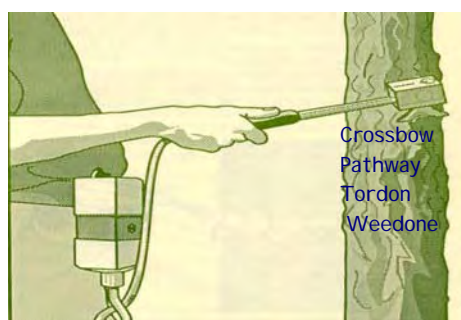
Figure 5c. Hypohachet application.

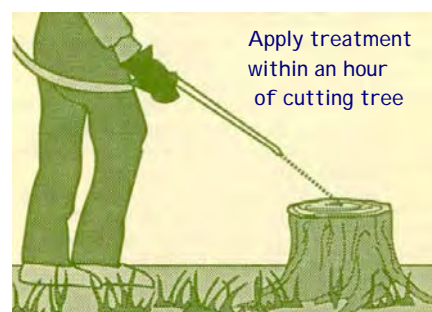
Figure 5d. Cut-stump application.

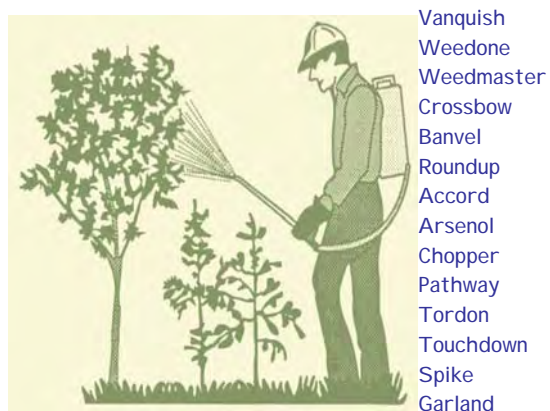
Figure 5e. Backpack foliar application on dam.

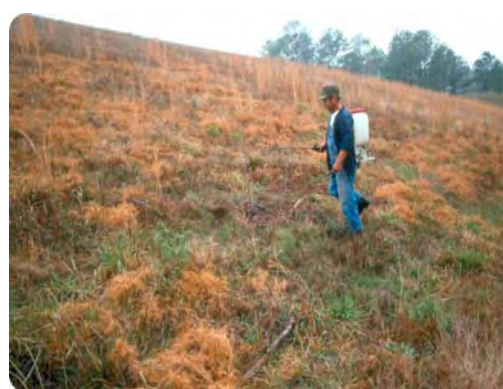
Figure 5. Applications and techniques for different herbicidal deliveries to trees and brush, with example commercially-available herbicides listed.

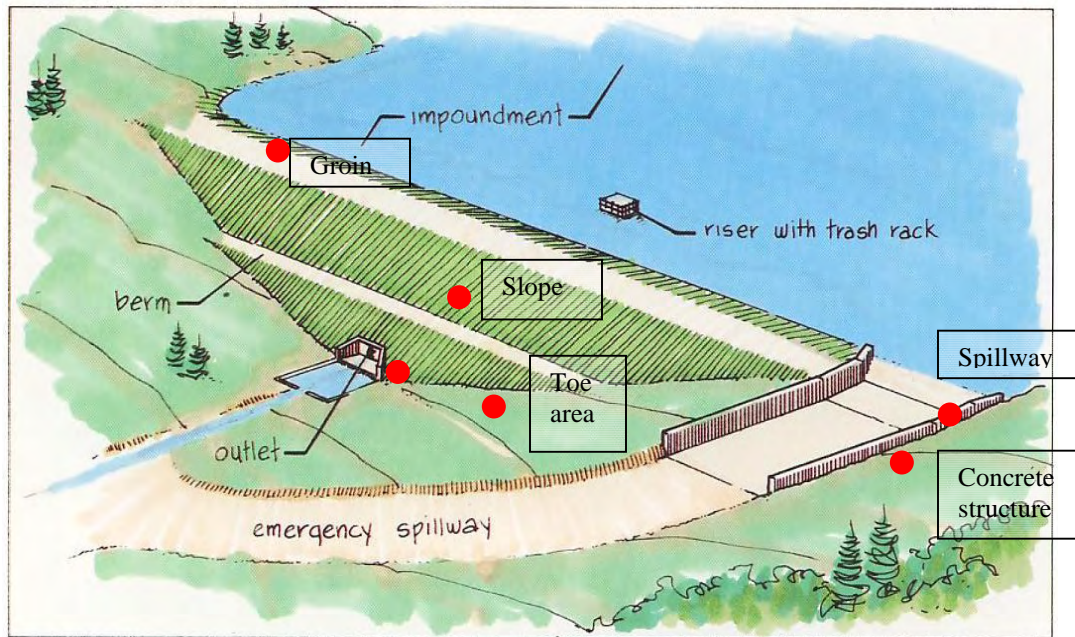
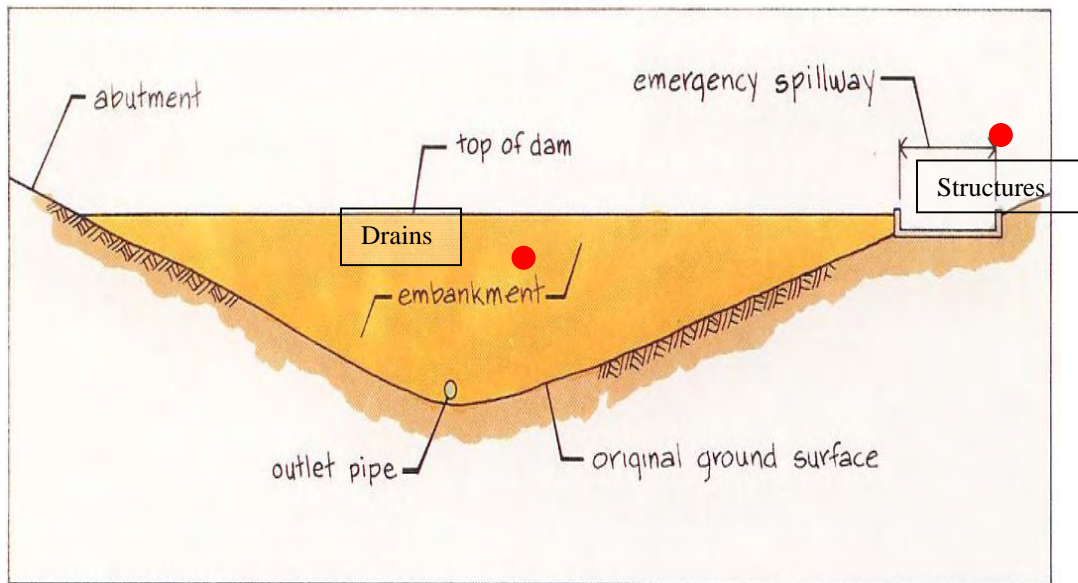
Figure 6. Tree clearance zones for embankment dams and dikes.

3. **Root exclusion zones** utilizing soil structure changes, soil compaction, water/aeration, stress, anaerobic conditions, soil injections and slurries, soil additives, and chemicals to prevent roots from colonizing the soil structure areas due to applied physical or chemical changes to the soil. Changing the soil structure, pore space volume or drainage/aeration matrices can generate a soil environment that roots cannot effectively grow and sustain. A variety of physical- or chemical-based soil altering materials (i.e., soil injected clay slurry or cement solutions) can be effective, at least over the short term if adequate soil volume is treated. Compacting soils appear to be a very good way to prevent root colonization. High density soils increase the resisting strength of these soils to root penetration and deprive the roots from needed oxygen and available water. Certain types of clay soils, freeze-thaw cycles, biological activity, and poor soil compaction can, over time, produce root-accessible pore space. Soil or infrastructure building material additives that neutralize or sterilize the available minerals and nutrients such as nitrogen gas, sulphur, sodium, zinc, borate, salts, or herbicides may produce serious environmental consequences, short-lived results, and non-targeted damage potential. Other methods or additives may be cost-prohibitive. See Figure 6 at end of chapter for root clearance zones.

8. **Creating avoidance zones** to separate tree growth from earthen dam embankments and dam appurtenances where root damage may be critical thus establishing biological-free zones that reduce potential problems. This method simply recognizes that there are places where trees are acceptable and other places, namely dams, where they are not (see Figure 6).

The reader is referred to the USDA guideline for detailed discussion on each of the six treatment methods listed in the above table. These methods can be applied to establish tree and woody plant clearance or avoidance zones on and around dams as illustrated in Figure 6.

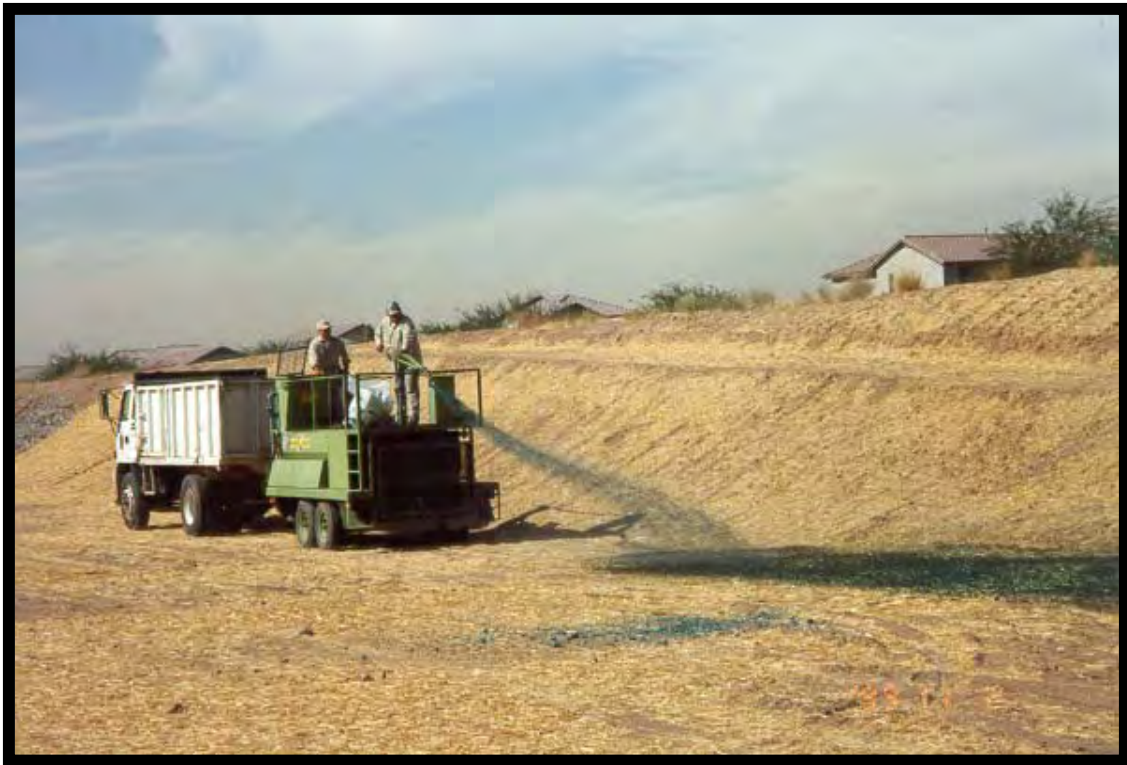
Figure 8. Hydro-seeding operations on a floodway dam in Maricopa County, Arizona (Renckly & Drake, 1999).

Revegetation on earthen dams is recommended to minimize erosion on the embankment slopes and to provide natural landscaping for earthen dams. MCFCD recommends hydro-seeding over labor-intensive hand-seeding to revegetate dam embankments. Figure 8 illustrates hydro-seeding operations on a floodway dam. Seed, water, tack material and a wood fiber or paper mulch are mixed in a hydro-seeder and sprayed directed onto the slopes. The seeds are encapsulated in the mulch and tack material until enough moisture is present to begin the germination process.

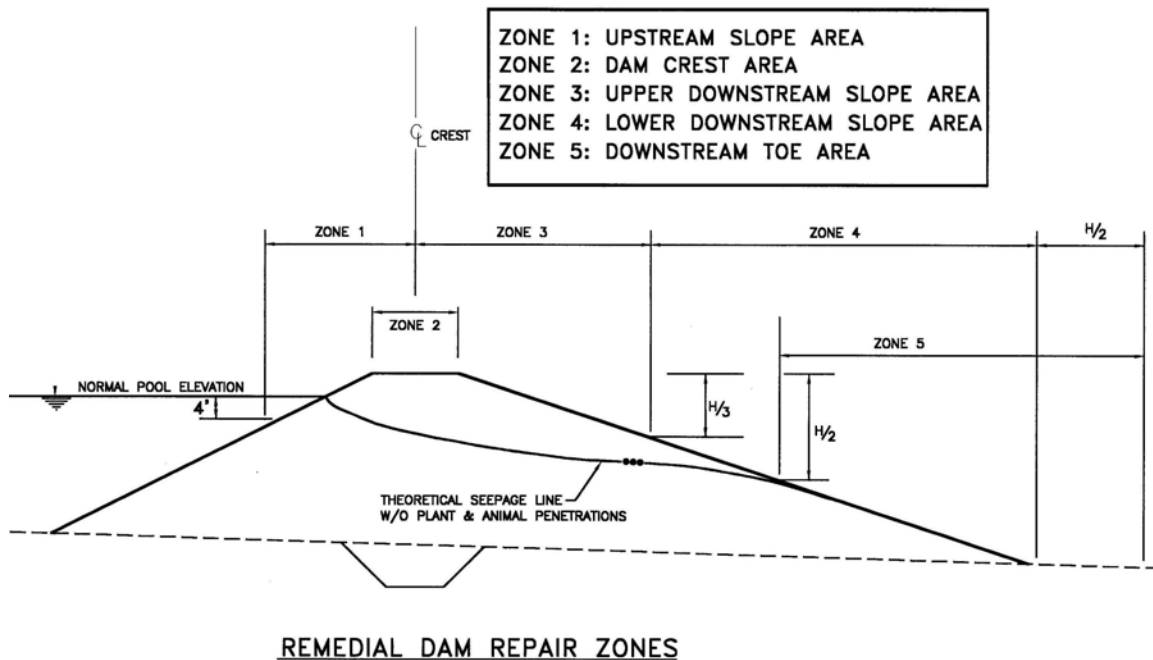
Specific dam remediation design considerations, procedures, and techniques will be considered for each of the previously identified dam safety inspection and evaluation zones. Figure 1 presents these zones as a review prior to discussion of potential dam remediation design considerations for each zone. Dam remediation design alternatives presented herein should be considered examples. These remediation design examples should not be considered the only alternatives for use in dam remediation design to correct deficiencies associated with tree and woody vegetation growth on earthen dams. Some additional dam remediation design alternatives presented for correction of tree and woody vegetation growth related deficiencies also provide positive correction of other deficiencies and protection against other types of earthen dam deterioration.

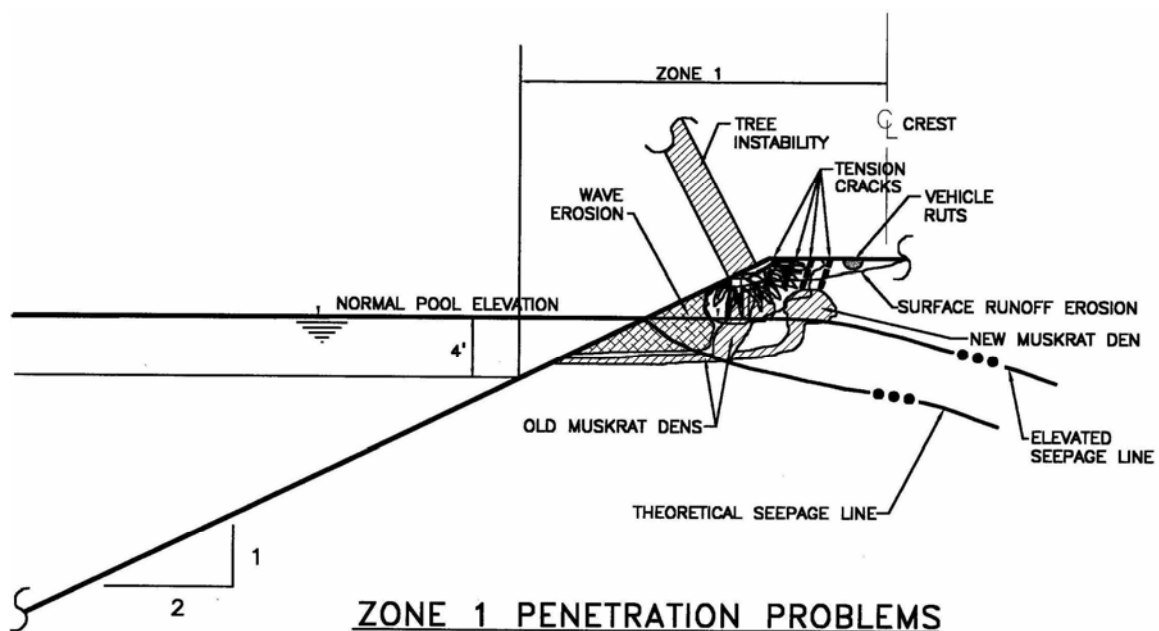
Figure 2 illustrates potential problems that can occur in Zone 1 with respect to tree and woody vegetation growth on earthen dams. This illustration also depicts the occurrence of wave erosion, vehicle access, and surface runoff erosion. Potential problems illustrated include instability of relatively large trees on the upstream slope and dam crest, and alteration of the seepage line as a result of wave erosion.

Dam remediation design techniques necessary to address potential problems illustrated in Figure 2 are illustrated in Figures 3 and 4. Dam remediation construction typically requires lowering of the normal pool elevation and/or complete drawdown of the retained reservoir. This is particularly true for dam remediation construction in Zone 1. The normal pool elevation should be lowered as far ahead of the scheduled dam remediation construction as practicable.

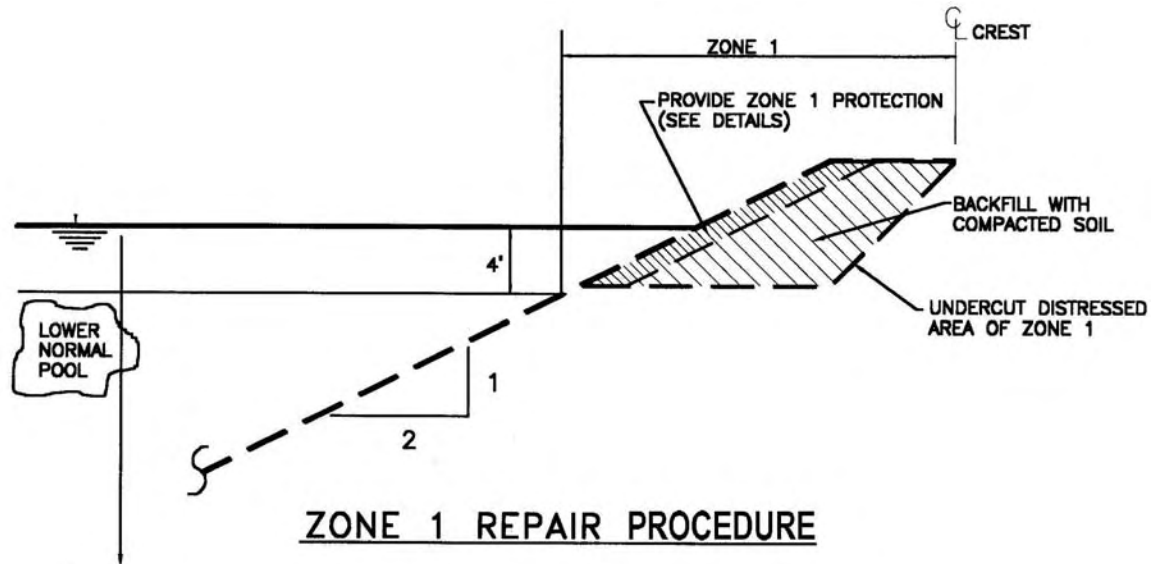
Figure 3

Tree and woody vegetation growth in Zone 1 must be undercut to remove all stumps, rootballs, and root systems developed by tree penetrations as illustrated in Figure 3. The required depth of undercutting typically extends to near the limits of Zone 1, which is about four feet below normal pool elevation. In the case of earthen dams with narrow crest widths, the backslope of the undercut area will typically extend to near the centerline of the dam crest or the downstream limits of Zone 1. Subsequent to undercutting affected areas of Zone 1, the undercut area must be thoroughly inspected to confirm that all major root systems (greater than about one-half inch in diameter) have been removed during the undercutting operation. Following inspection and approval of the undercut area by the engineer, suitable backfill should be placed in the excavation and properly compacted to the dam remediation design limits. Backfill should consist of approved embankment fill material and should be compacted to a minimum of 95 percent of the maximum dry density of the fill soil as determined by the standard Proctor compaction test (ASTM D-698). In conjunction with the undercutting and backfilling, the dam remediation design should include a slope protection system to deter future tree and woody vegetation growth and reduce the potential for wave and surface runoff erosion.
