Course Number: CE-02-207

Technical Manual for Dam Owners

Impacts of Plants on Earthen Dams

FEMA 534 / September 2005

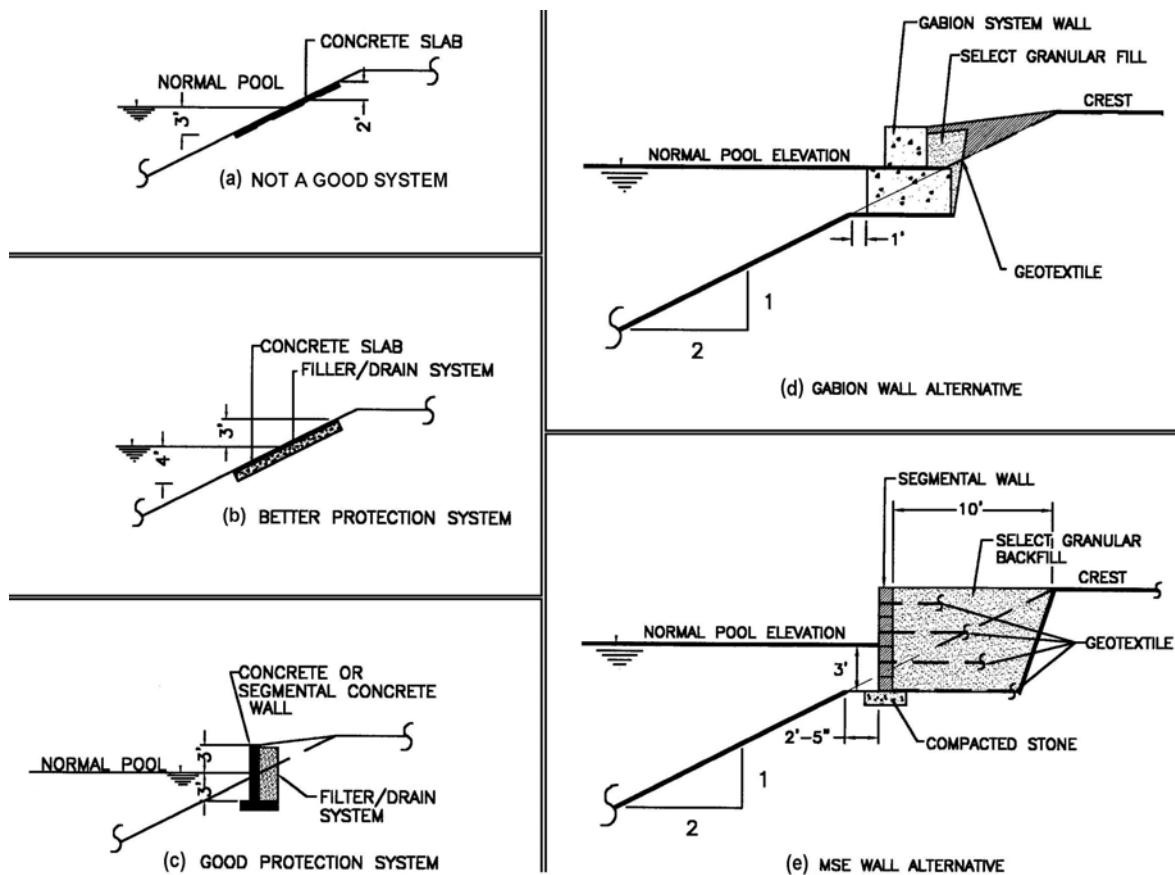
Figure 4

Figures 4(a) through 4(c) illustrate various configurations of rigid (concrete) upstream embankment slope protection systems. Figure 4(a) illustrates a concrete slab being placed directly on the upstream slope from about three feet below to about two feet above normal pool elevation. While this system is somewhat limited relative to the area of protection, the most critical aspect of this system is that it provides no filtration and/or drainage system beneath the concrete slab. Continual wave action and the buildup of hydrostatic pressures beneath the concrete slab will eventually result in downward movement of the slab. Figure 4(b) illustrates a better dam remediation design utilizing a concrete slab slope protection system. This slope protection system has been improved over the original system by covering a larger area of the upstream slope and by providing a filter system beneath the concrete slab protection system. The author is of the opinion

Dam remediation design techniques necessary to address potential problems illustrated in Figure 2 are illustrated in Figures 3 and 4. Dam remediation construction typically requires lowering of the normal pool elevation and/or complete drawdown of the retained reservoir. This is particularly true for dam remediation construction in Zone 1. The normal pool elevation should be lowered as far ahead of the scheduled dam remediation construction as practicable.

NOTE: Reinforced concrete wall and slab systems constructed on the upstream slope must always be provided with filtration/drainage systems to reduce the potential for development of excessive hydrostatic pressures and internal erosion and scour of soil from beneath the structures. The referenced figures are presented for illustrative purposes and should not be used for actual dam remediation design without proper design analyses to confirm any indicated dimensions of the drawings.

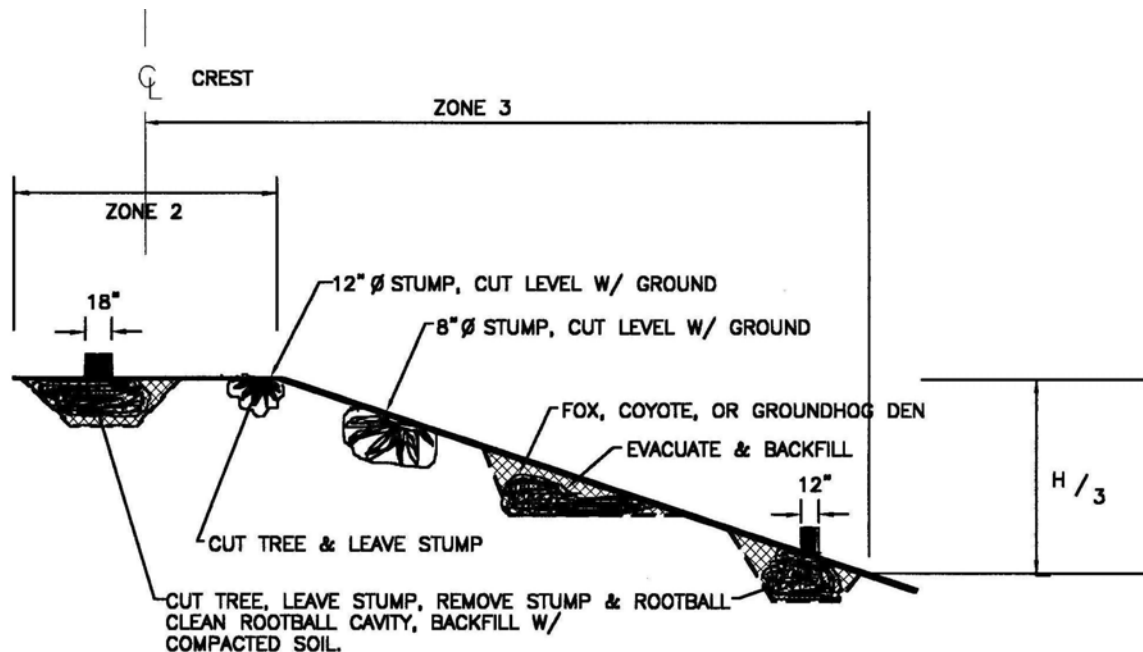
Potential problems associated with tree and woody vegetation growth on earthen dams in identified Zones 2 and 3 are illustrated with dam remediation design procedures in Figure 5. Potential problems illustrated for Zone 2 include the growth of mature trees having stump diameters greater than twelve inches. Mature trees having stump diameters greater than eight inches are illustrated at various locations throughout Zone 3 and in the overlap area of Zones 2 and 3.

ZONE 2 & 3 REPAIR PROCEDURES

Two dam remediation design procedures are illustrated in Figure 5 for removal of trees of various sizes. This illustration implies that trees located in the overlap area of Zones 2 and 3 having stump diameters less than about twelve inches could be cut flush with the ground and left in place for future treatment of the decayed stump and rootball system. However, removal of all stumps, rootballs and root systems is always the better and more conservative approach to removal of mature trees. Subsequent to cutting of trees having stump diameter less than about twelve inches in the overlap area of Zones 2 and 3, the surface of the stump can be treated with a protective coating similar to polyurethane that will prolong the decaying process. Conversely, the referenced illustration indicates that any trees in Zone 2 upstream of the overlap area of Zones 2 and 3 having stump diameters of twelve inches or greater should be treated by total removal of the tree, stump, rootball, and root system. The suggested dam remediation design and construction procedure suggested for complete removal of trees, stumps, rootballs, and root systems in Zones 2 and 3 consists of the following activities:

1. **Cut** the tree approximately two feet above ground leaving a well-defined stump that can be used in the rootball removal process;
2. **Remove** the stump and rootball by pulling the stump, or by using a track-mounted backhoe to first loosen the rootball by pulling on the stump and then extracting the stump and rootball all together (this is much the same procedure a dentist would use in extracting a tooth);

3. **Remove** the remaining root system and loose soil from the rootball cavity by excavating the sides of the cavity to slopes no steeper than 1:1 (horizontal to vertical) and the bottom of the cavity approximately horizontal; and

4. **Backfill** the excavation with well-compacted soil placed in relatively thin lifts not greater than about eight inches in loose lift thickness. Compaction of backfilled soils in these tree stump and rootball excavations typically requires the use of manually operated compaction equipment or compaction equipment attached to a backhoe.

Figure 5 further illustrates that trees located in Zone 3 that have stump diameters greater than about eight inches should be treated by total removal. The removal procedure should be the same as previously described for larger trees in Zone 2. Trees having stump diameter of less than about eight inches could be cut flush with the ground and treated with a waterproofing sealant similar to polyurethane to prolong the stump and rootball decaying process. Again, complete removal of the stumps, rootballs, and root systems of all mature trees is a better and more conservative method of remediation.

Cut trees in overlap area of Zone 2 and Zone 3 having stump diameters of twelve inches or less flush with the ground and treat the stump with a waterproof sealant to prolong stump decay.

Cut trees having stump diameters of about eight inches and less level with the ground and treat the stump with a waterproof sealant to prolong stump and rootball decay.

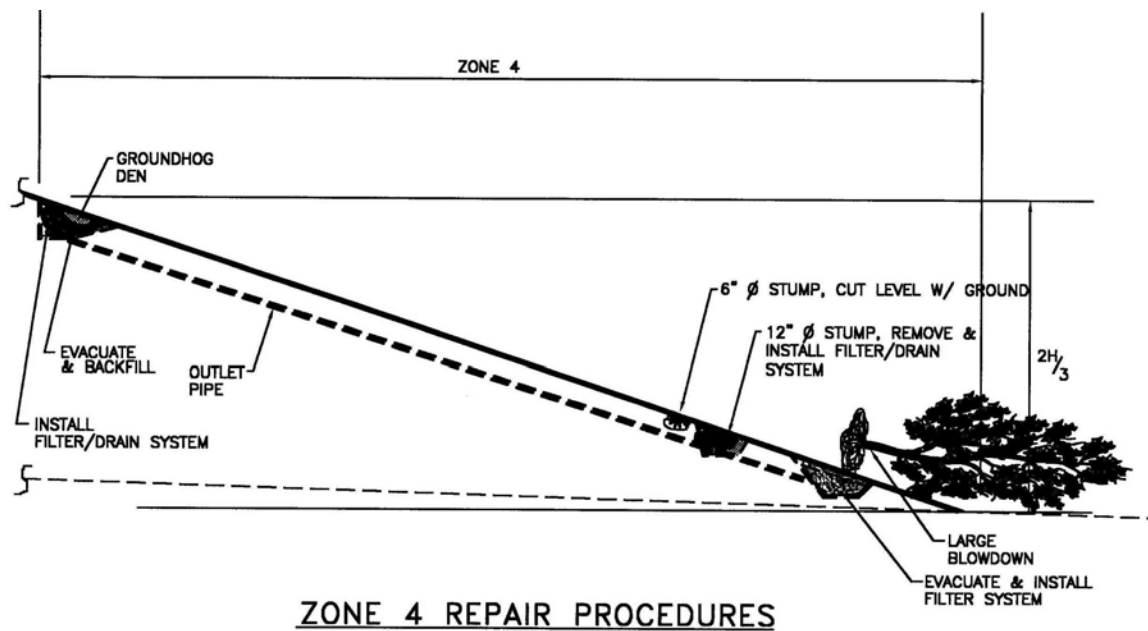
Figure 6 illustrates potential problems associated with tree and woody vegetation growth in Zone 4 of an earthen dam with suggested dam remediation design and construction procedures.

Young immature trees having stump diameters less than about six inches can be removed by cutting flush with the ground and treating the stump with a wood preservative and/or sealant to prolong the decaying process. This procedure is based upon the fact that immature trees of this size typically have not developed a rootball and/or root system that will significantly impact the zone of saturation or the seepage line in Zone 4.

1. **Cut** the tree approximately two feet above ground level leaving a prominent stump for use in the rootball extraction process;
2. **Remove** the stump and rootball by pulling the stump or extracting with a track-mounted backhoe after loosening the rootball by pulling on the stump from different directions;
3. **Clean** the rootball cavity to remove loose soil and the remaining root system by excavating the rootball cavity with maximum 1:1 (horizontal to vertical) side slopes and a horizontal bottom; and
4. **Install** a subdrain and/or filter system in the tree penetration excavation and backfill with compacted soil placed in maximum loose lifts of eight inches.

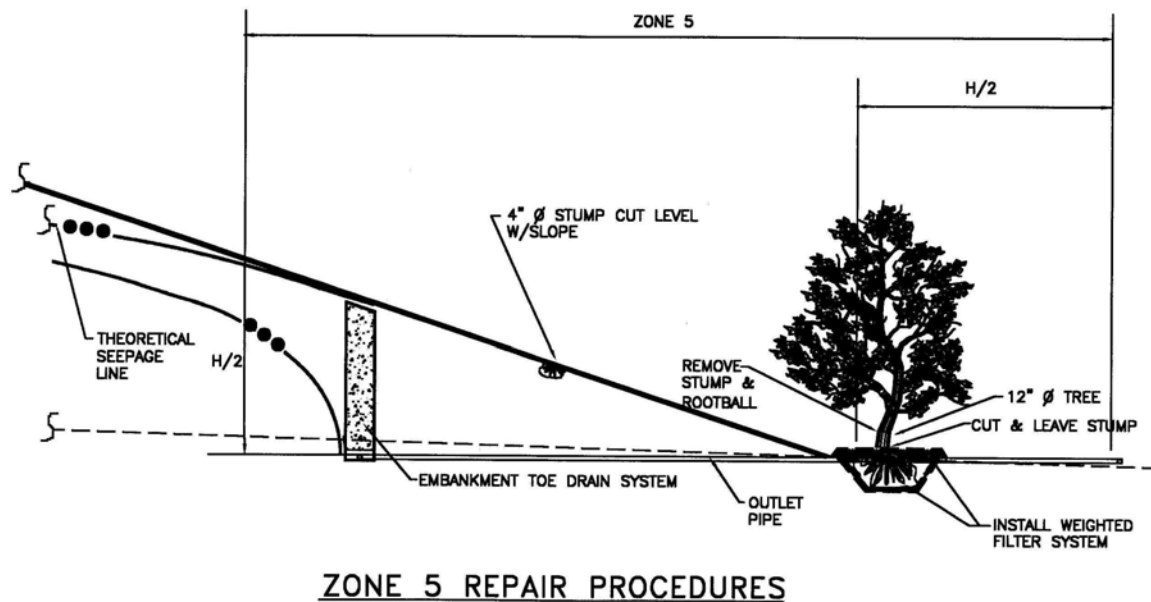
The author identified Zone 5 as one of the two most critical zones for tree and woody vegetation growth on an earthen dam. Figure 7 illustrates some of the problems that can occur with tree and woody vegetation growth in Zone 5. The major adverse feature in Zone 5 is typically the interception of the downstream embankment slope by the seepage line. The author is a strong advocate of the installation of embankment subdrain systems during dam remediation design and construction even though the earthen dam may have been provided with an embankment subdrain system during original design and construction.

One must understand the impact of tree removal in Zone 5 on the seepage line and the quantity of seepage that will occur subsequent to dam remediation in this zone. As indicated by Figure 7, trees in Zone 5 having stump diameters less than about four inches can be cut flush with the ground and the stump treated with a waterproof sealant to

prolong stump and rootball decay. Trees having stump diameters greater than about four inches must be removed completely. If the embankment toe drain or subdrain system is installed in advance of tree removal in Zone 5, the rootball cavity can be backfilled with compacted soil, provided seepage does not emerge from the excavation and/or the tree is located beyond the toe of the embankment slope. Tree rootball cavities existing beyond the toe of the downstream embankment slope generally require the installation of a filter system and in some cases a weighted filter system as indicated in Figure 7. The weighted filter system may be converted to a weighted drain system by installing a drain and outlet pipes connected to the outlet pipe of the embankment subdrain system.

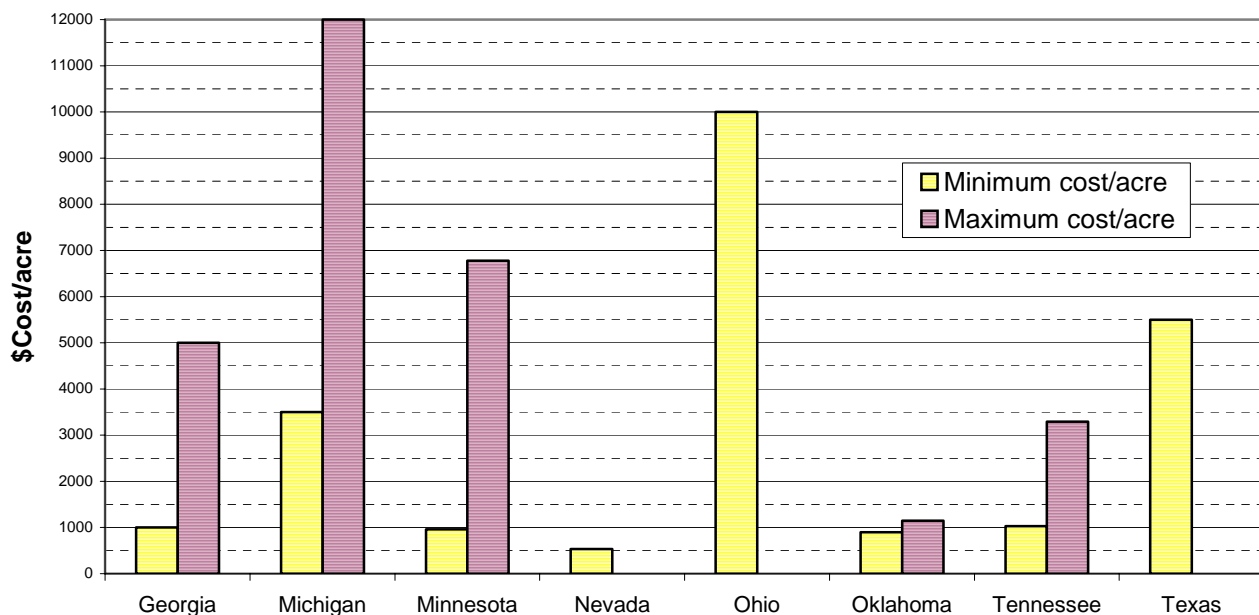
Figure 2. Comparison of tree removal costs per acre of dam surface area reported by 8 states.

The reader is referred to Table 1 in Chapter 2 and Figure 2 below for unit area tree removal cost comparison experiences reported in a survey by eight state dam safety officials in different regions of the country. The survey data shows that the cost of clearing and grubbing trees and other woody vegetation varies widely within and among states, but generally ranges from about \$1000 to \$5000 per acre, depending on site-specific conditions (Tschantz, 2000).

These data compare favorably with the \$1500 - \$3000 bid price data for three Southeastern states discussed earlier in Chapter 2 for cutting trees, removing stumps and rootballs, and grubbing the area to remove roots for different dam conditions. While not included in the above Figure 2 chart data, Massachusetts' dam safety personnel reported in 2000 that, based on its own in-house experience, some local consultants and other sources, "broad area" tree removal costs ranged from \$5000 and \$6000 per acre or from about \$800 to \$1000 for individual 18-24 inch trees in their region. One dam safety official, from Tennessee, provided detailed cost data for clearing trees from seven dams in that state from 1995-1999. The cost for clearing and grubbing trees and for reseeding for one typical dam in 1998 is described for the reader in Table 1.

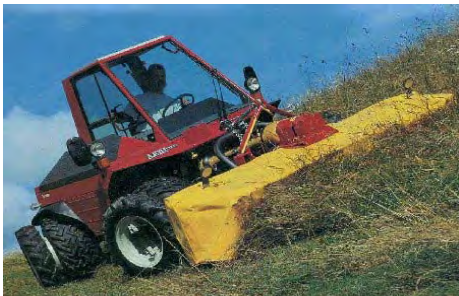
Figure 3. Example of slope mower
(Terratrac© photo used with
permission from AEBI North
America, Inc.)

Figure 3 illustrates the use of a slope mower for easing the burden of maintenance for state and federal agencies and for other multiple or large dam owners.

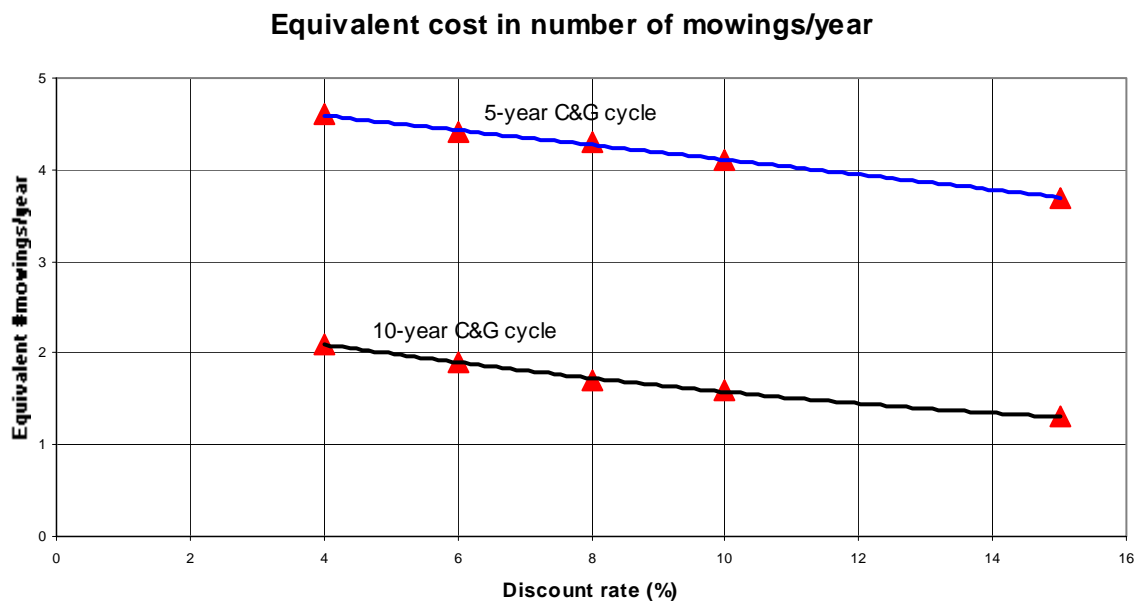
Figure 4. Comparison of Annual Tree Clearing and Grubbing Costs for 5 and 10-Year \$2500/acre payouts.

For a more conservative 5-year tree growth cycle and a \$2500 clearing and grubbing cost assumption, the annualized clearing and grubbing costs would be \$1523, \$1464, \$1406, \$1351, and \$1224 for the same discount rates, respectively. The corresponding justifiable mowings would be 4.6, 4.4, 4.3, 4.1, and 3.7 per year. Similarly, justifiable mowings for an assumed \$5000 clearing and grubbing cost would double the justifiable mowings to 9.2, 8.9, 8.6, 8.2, and 7.4 per year. Figure 4 compares 5 and 10-year annualized costs for \$2500/acre clearing and grubbing payouts.

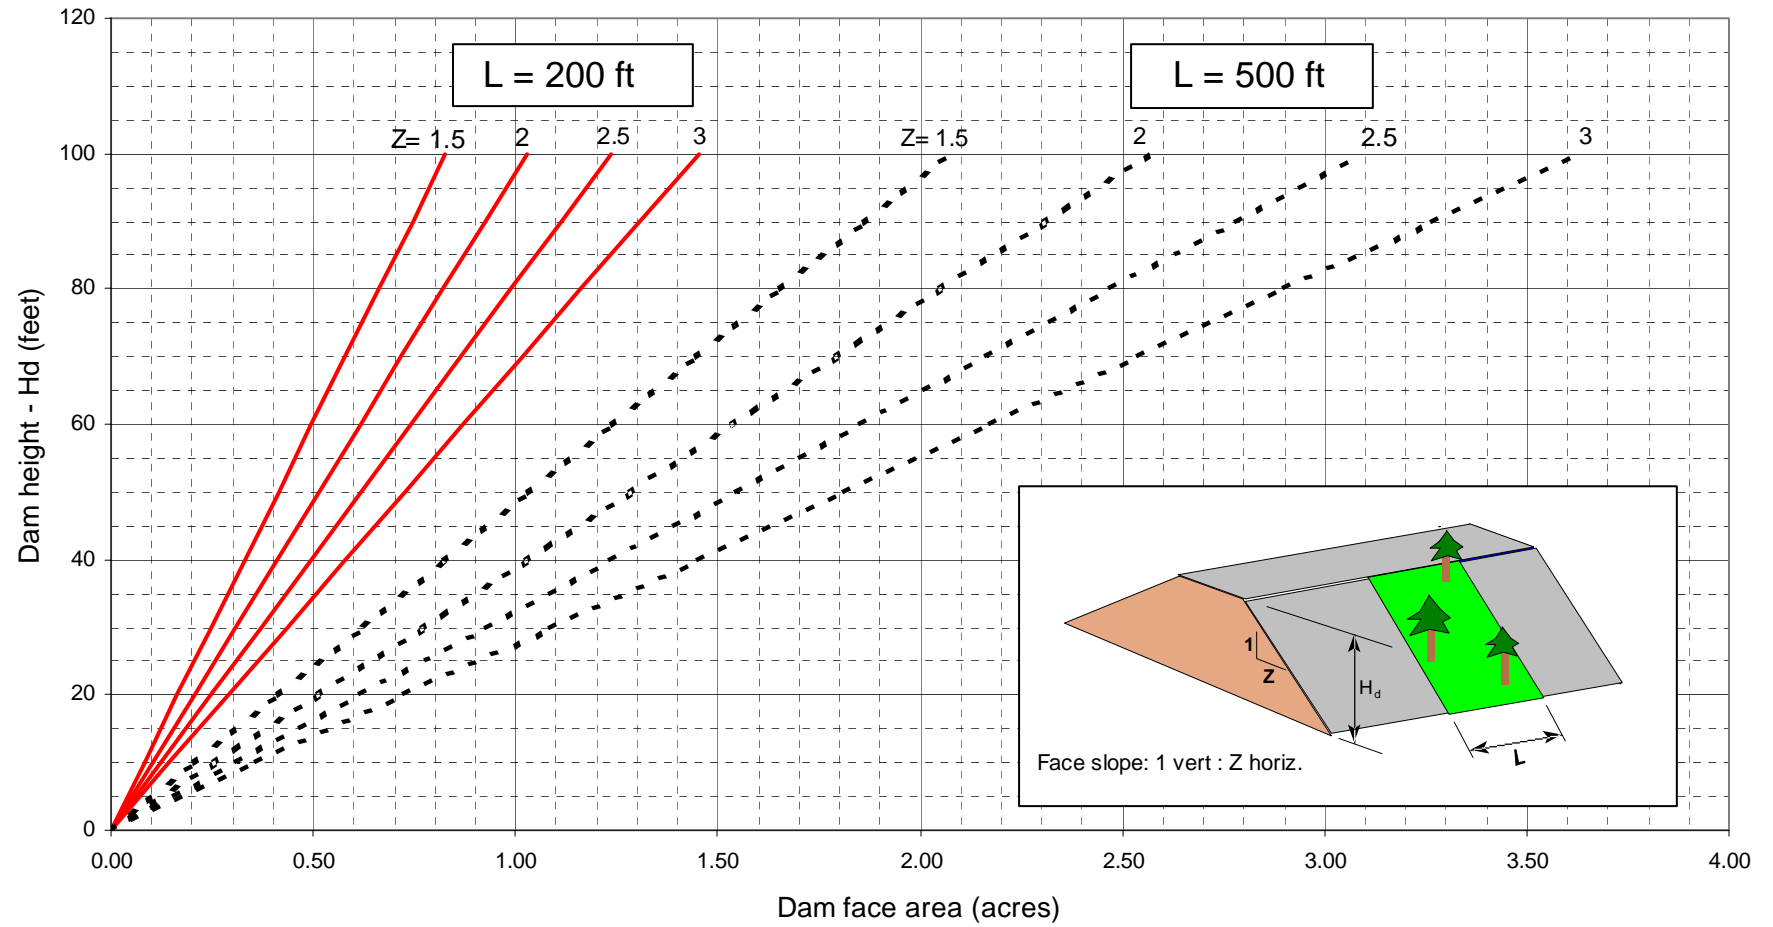
Chart 1. Dam face area for different geometries

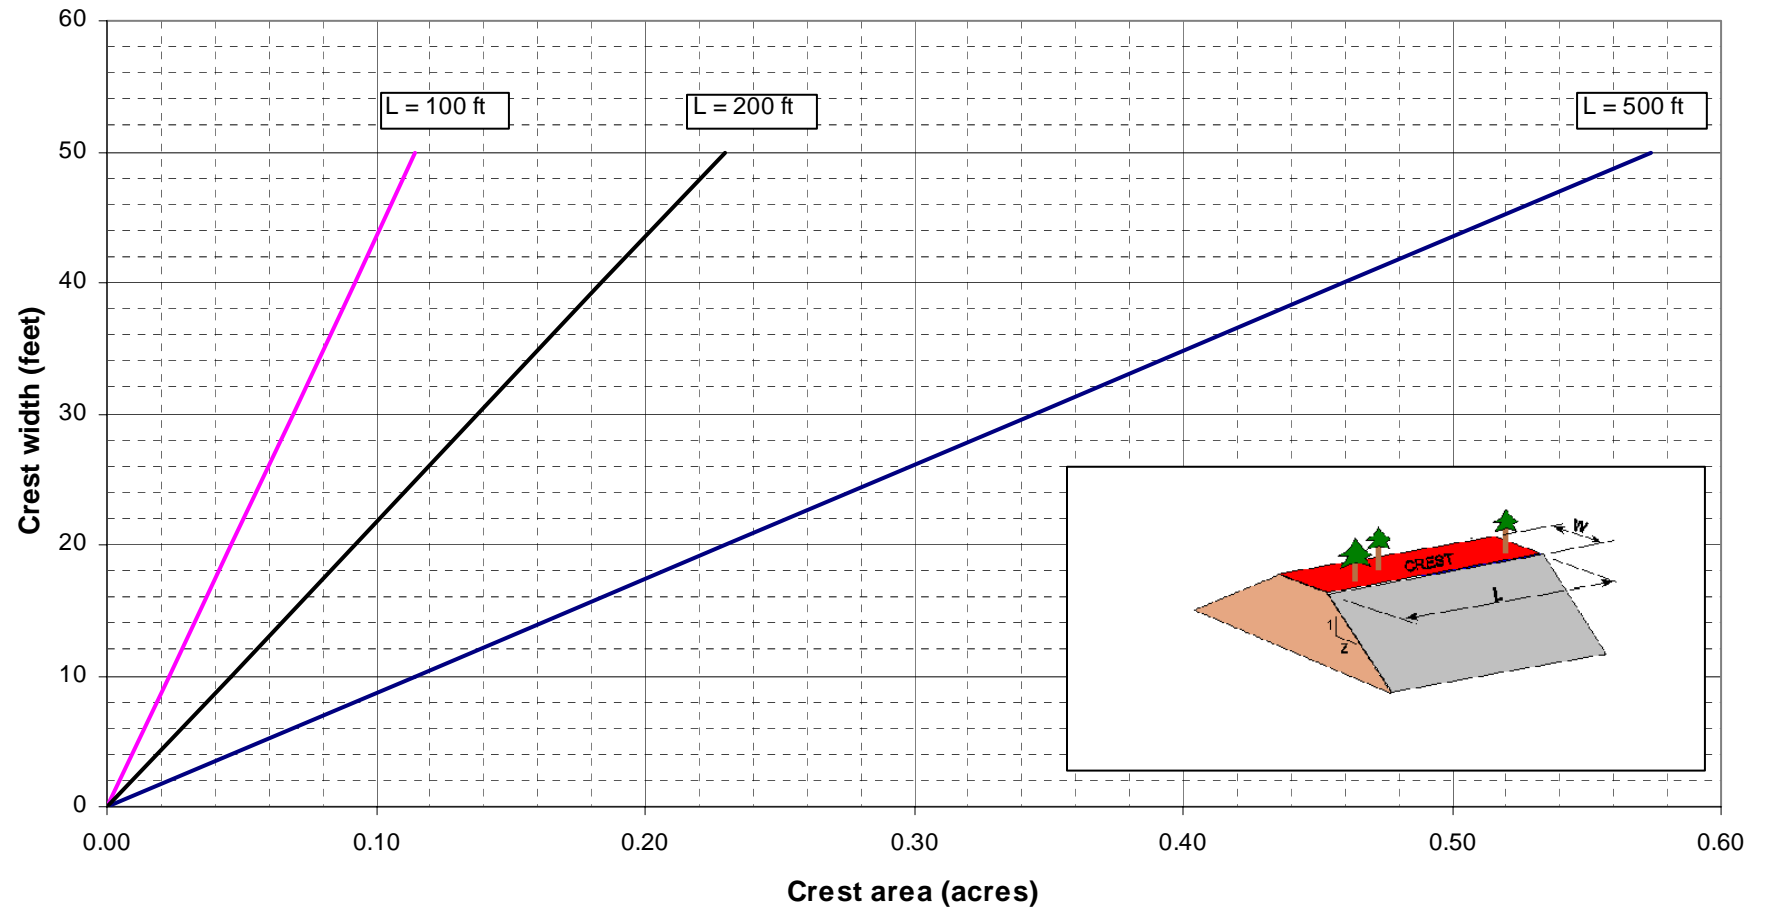
Chart 2. Dam crest area by width and length

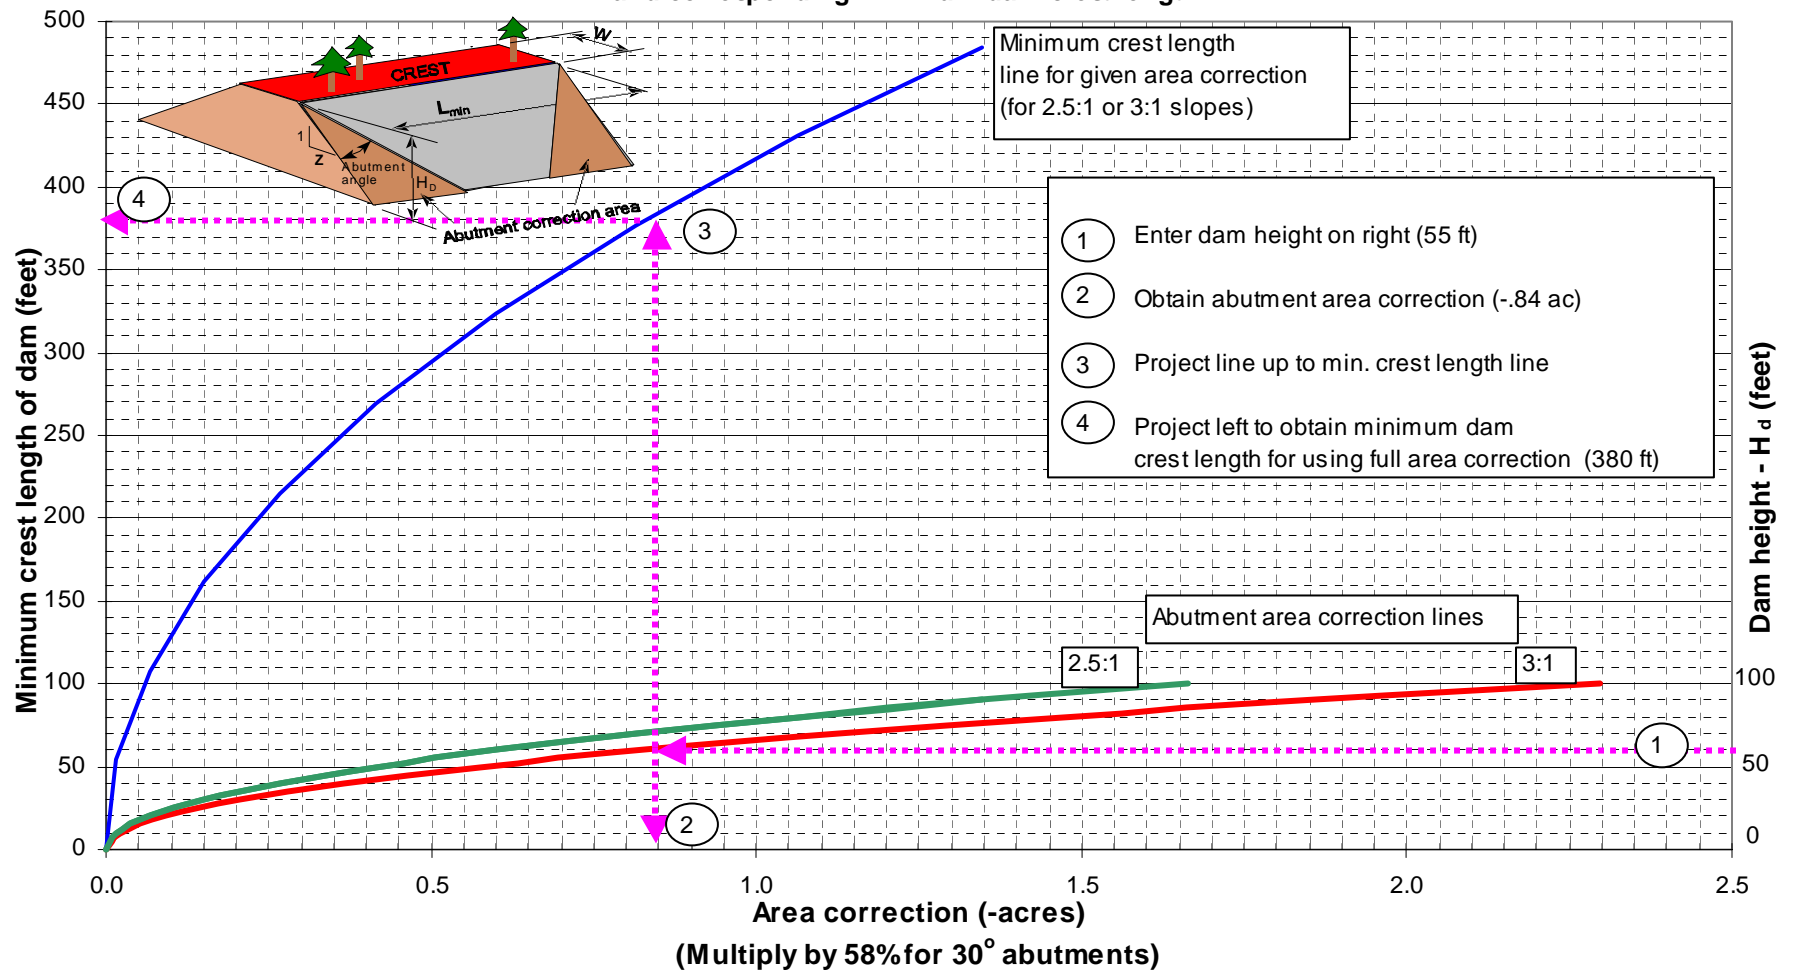
Chart 3. Abutment area corrections vs. dam height for 2.5H:1V & 3H:1V side slopes, with 45° abutment angle and corresponding minimum dam crest length
