Technical Manual for Dam Owners

Impacts of Plants on Earthen Dams

FEMA 534 / September 2005

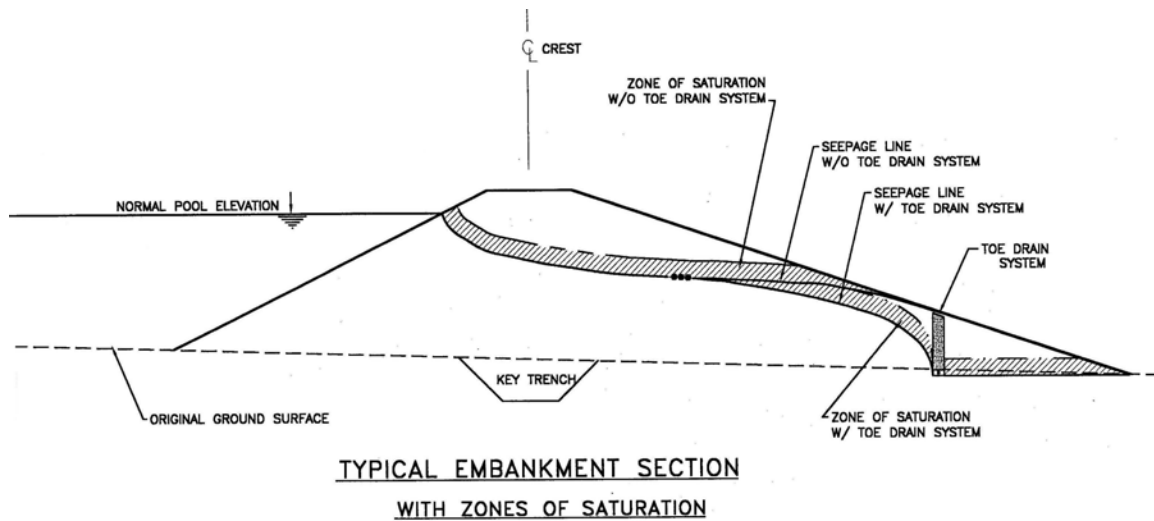
Important moisture regimes other than the steady-state seepage line (phreatic surface) are often not given proper consideration in the evaluation of the performance of earthen dams. The *zone of saturation* is located immediately above the phreatic surface or seepage line where embankment fill soils have become saturated as a result of capillary rise caused by capillary forces in the soil voids. Figure 3 illustrates the presence of zones of saturation associated with that of a theoretical seepage line location without an embankment subdrain system as well as that of a modified seepage line location with an embankment toe drain system. The height of capillary rise (thickness of the zone of saturation) is directly dependent upon the effective mean diameter of soil voids within the earthen dam embankment. The effective mean diameter of compacted soil is dependent upon the *effective particle size* (D_e) of the compacted embankment fill soil. Soil within

the zone of saturation is completely saturated; however, there is no flow or gravity induced movement of water unless some external force disturbs the soil. This phenomenon is often observable during the inspection of downstream slopes of earthen

dams. Seepage and free flowing water can be seen on the downstream slope of an older dam below the point of interception of the seepage line if no embankment subdrain is present. Above the point of interception of the seepage line with the downstream slope, the soil is saturated and the Zone of Saturation can be observed for a significant distance above the seepage line intercept in some cases. In the Zone of Saturation, pore water may be observed to fill tracks made in the water-softened embankment soil. However, once the tracks are filled by pore water released from the disturbed soil there will be no continued flow or seepage from the embankment. This condition is often confused with the presence of embankment seepage. Installation of a subdrain location in this situation may lower the phreatic surface relatively quickly; however, months or even years may be required to drain the zone of saturation because of tensile forces or negative pore pressures in the embankment fill soils.

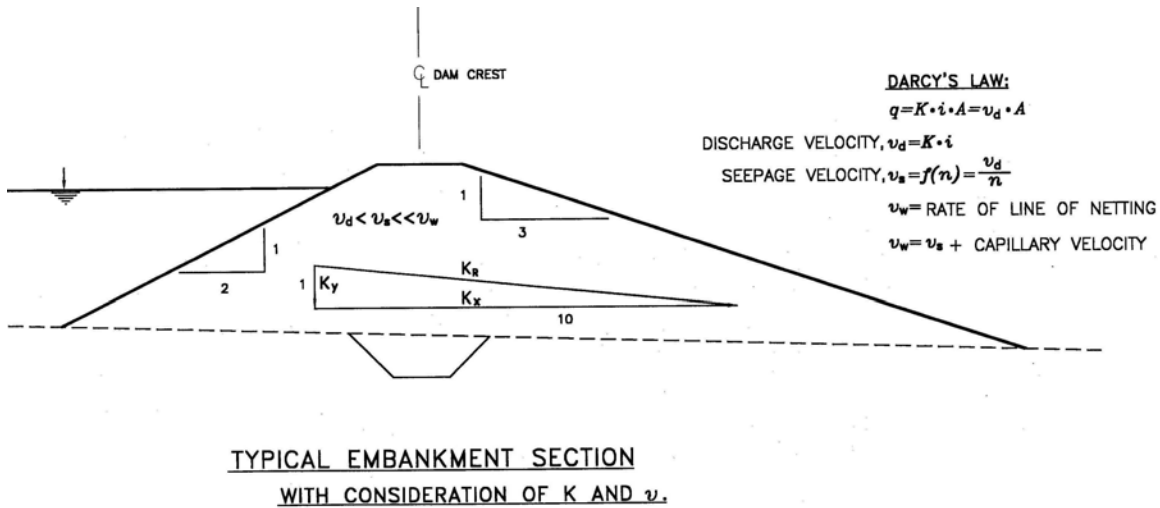
Figure 4 is an illustration of the example earthen dam with relationships between various soil water flow velocities and permeabilities. First, consider the relationship between the vertical and horizontal permeability of a compacted homogeneous embankment soil.

Rule-of-Thumb: *The horizontal permeability of a compacted homogeneous embankment soils are typically about nine times to ten times (one order of magnitude) greater than the vertical permeability.*

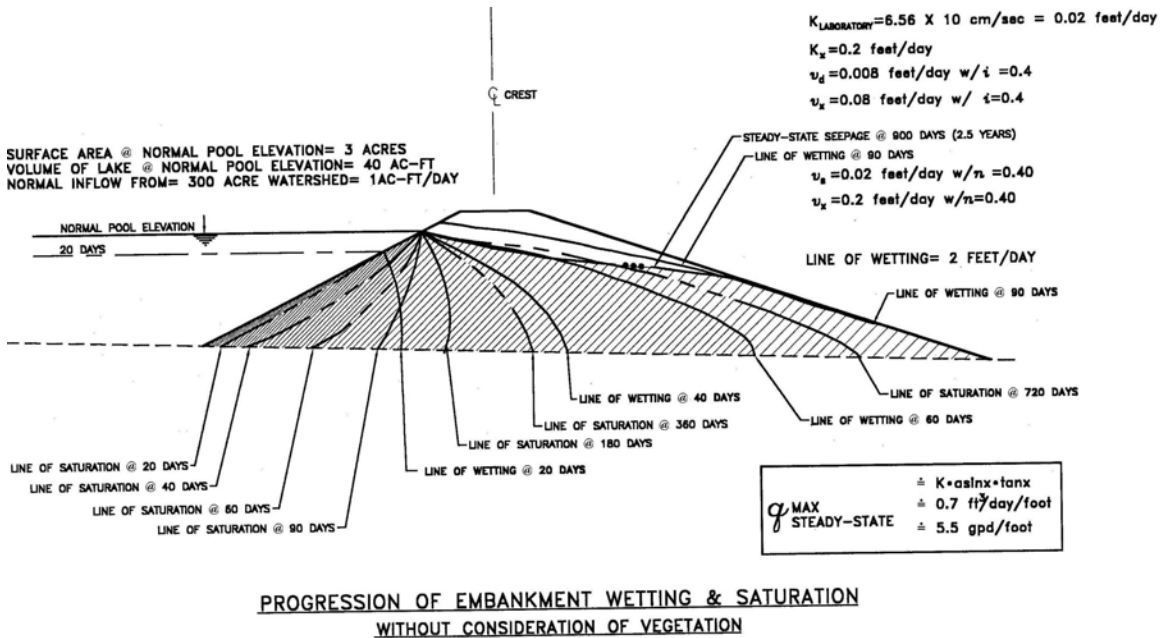
Based upon the estimated normal inflow from the contributing watershed, the lake retained by the example dam should reach about fifty percent volume in approximately twenty days and reach normal pool elevation in about forty days. Solid lines in Figure 5 illustrate the location of the line of wetting at various time intervals. The line of wetting should reach the downstream slope in about ninety days. *Note: The compacted embankment soils remain partially saturated after passage of the line of wetting.* Dashed lines in Figure 5 illustrate the line of saturation at various time intervals. The line of saturation moves at the seepage velocity that is about one-tenth the value of the wetting velocity. When the line of wetting has reached the downstream slope in about ninety days, the line of saturation is still at about the vertical from the intercept of the normal pool with the upstream slope. Based upon this rate of progression, the line of saturation will not reach the surface of the downstream slope and steady-state seepage will not be initiated for about 900 days (about 2.5 years), *provided that no external influences affect the rate of wetting and saturation.*

Applying this factor to the previous comparison between seepage velocity and discharge velocity, one finds that the wetting velocity is about 25 times greater than the discharge velocity. Based upon the foregoing discussion of earthen dam embankment wetting, saturation, and steady-state seepage velocities, consider the illustration in Figure 5. This figure illustrates embankment wetting, saturation, and steady-state seepage during the early years of the design life of an earthen dam. Assume that laboratory testing indicates that embankment soils of the example dam embankment have a permeability or hydraulic conductivity value of 0.02 foot per day. The discharge velocity would be about 0.008 foot per day with a hydraulic gradient of about 0.4 resulting in a horizontal discharge velocity of about 0.08 foot per day. The associated seepage velocity would be about 0.02 foot per day with a soil porosity of about 40 percent and the horizontal seepage velocity would be about 0.2 foot per day. The velocity of the line of wetting or the wetting velocity would be about 2.0 feet per day.

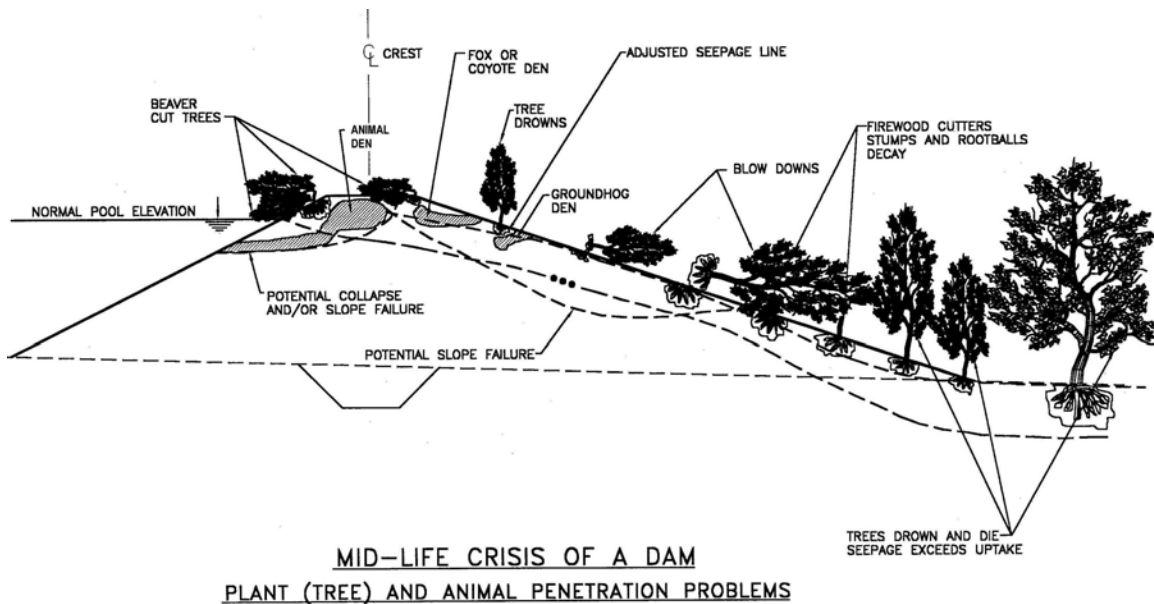
Figure 7 illustrates some of the problems and dam safety issues that can be created by uncontrolled or non-maintained tree and woody vegetation growth in what has been termed by the author as the '*Mid-Life Crisis*' of an earthen dam. Seepage flow may be emerging from rootball cavities of blowdowns (uprooted trees) because they are no longer using soil moisture and the seepage line has adjusted upward toward the surface of

the slope. Removal of mature trees by woodcutters deletes the soil moisture uptake of the removed trees thus further modifying the location of the seepage line closer to the surface of the downstream slope. Rootballs and root systems of otherwise healthy trees located at and beyond the toe of the downstream embankment slope become inundated by the adjusted seepage line. Since trees cannot live through prolonged submergence of their major root systems, these trees will become unhealthy and die leaving decaying rootballs and root systems as serious penetrations in the earthen dam. Rootball cavities remaining from blowdowns (uprooted trees) and their relationship to the seepage line create conditions susceptible to potential slope failure of the downstream embankment slope. Restoration of the example earthen dam illustrated in Figure 7 to a safe condition cannot be brought about through routine maintenance activities. An *engineered* dam remediation design and remediation construction will be required to restore this dam to a safe condition and original design life.

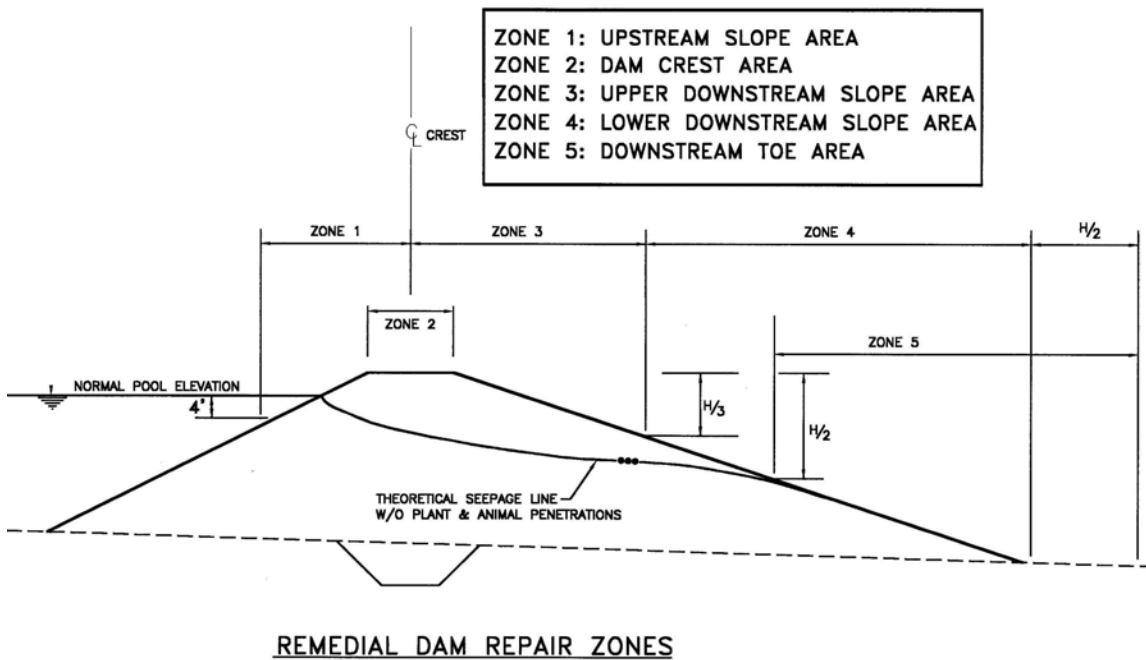
Figure 8

Five dam safety inspection and evaluation zones have been identified within the geometric configuration of a typical earthen dam. The delineated zones, illustrated in Figure 8, are not numbered in any implied order of seriousness relative to the impact of tree and woody vegetation growth, but have simply been numbered from upstream to downstream. The seriousness and potential impacts of tree and woody vegetation growth within each inspection and evaluation zone will be discussed during the description and identification of the delineated dam safety inspection and evaluation zones.

Inspection and Evaluation Zone 1 begins on the upstream slope of the earthen dam embankment at about four feet below normal pool elevation. Zone 1 extends laterally to the centerline of the crest of the dam. Tree and woody vegetation growth in Zone 1 is more critical relative to dam safety in the case of dams having a narrow crest width than those having a wide crest width. Zone 1 also includes the area subject to damage resulting from wave erosion and frequently recurring rapid drawdown events.

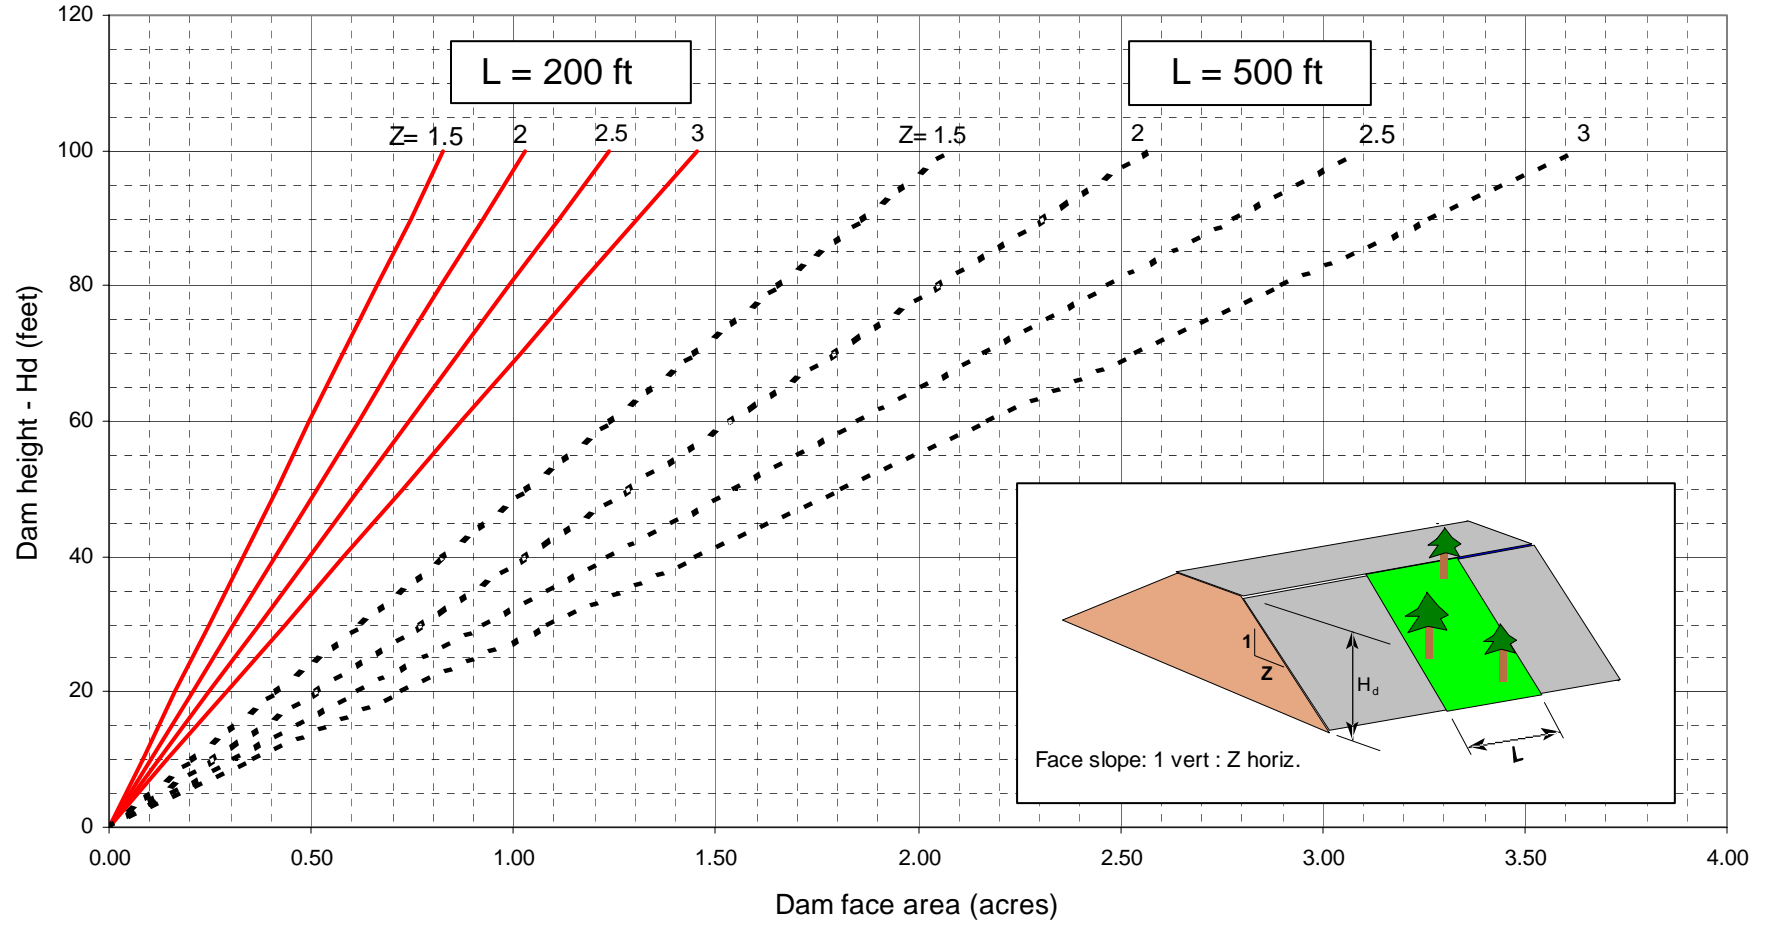
Chart 1. Dam face area for different geometries
